MONTHLY PROGRESS REPORT

RESTORATION AND RENOVATION OF THE SETH VENTRESS BUILDING

76 SOUTH RIVER STREET, MARSHFIELD, MA

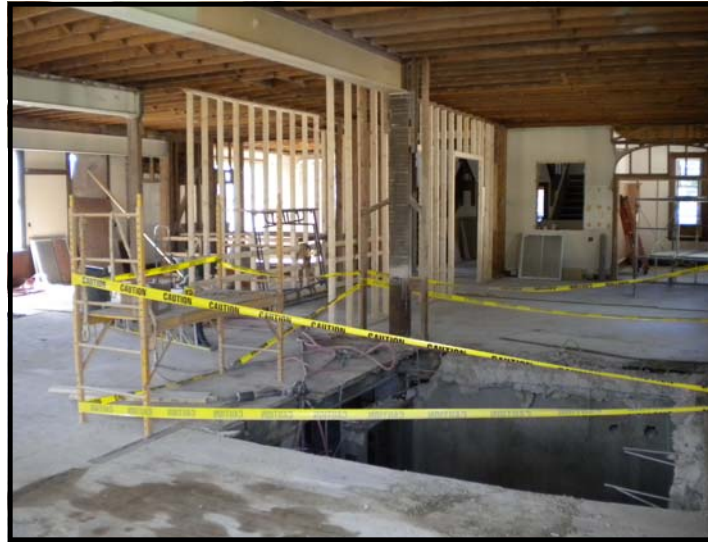
1

View of completed 1st floor vault demo.

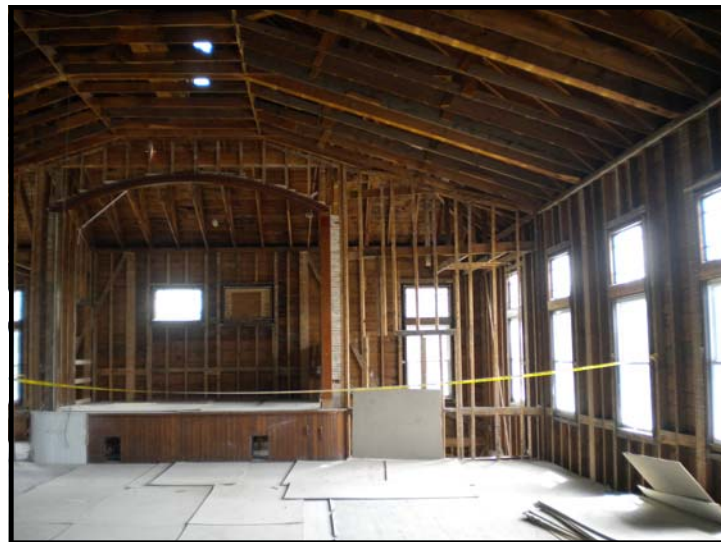
2

View of complete 2nd floor demo.

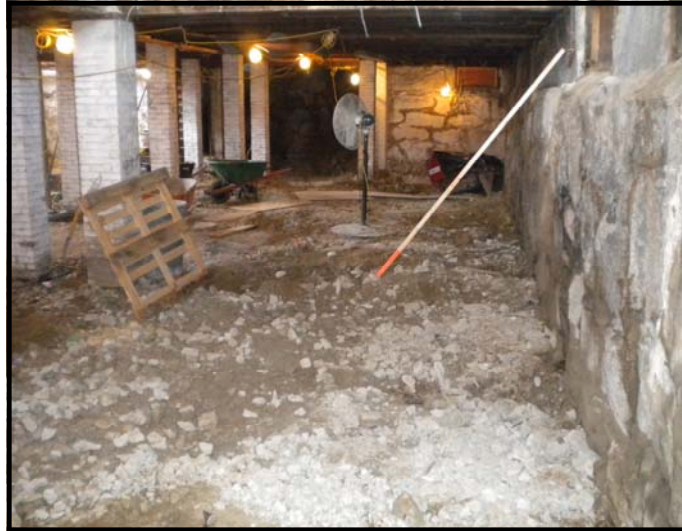
3

View of Basement floor slab demolition.

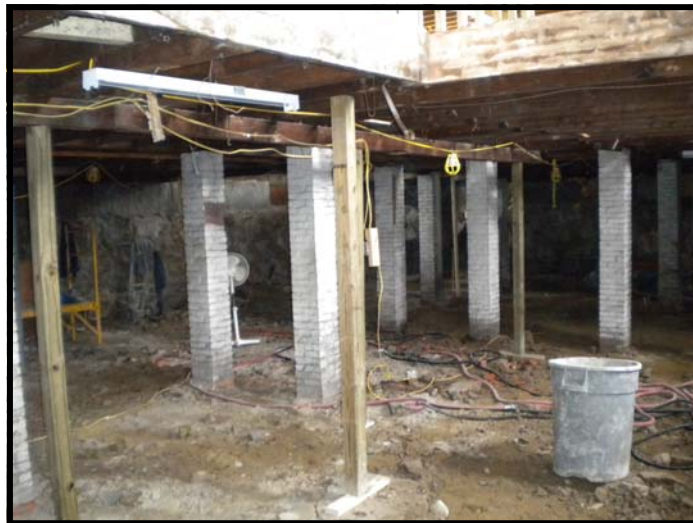
4

Basement view of former brick vault location (note ceiling open to first floor).

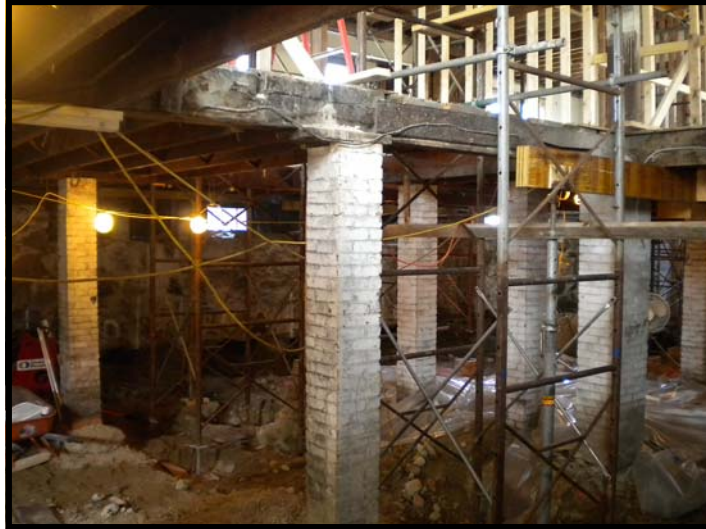
5

Basement view of former brick vault location during temporary shoring installation.

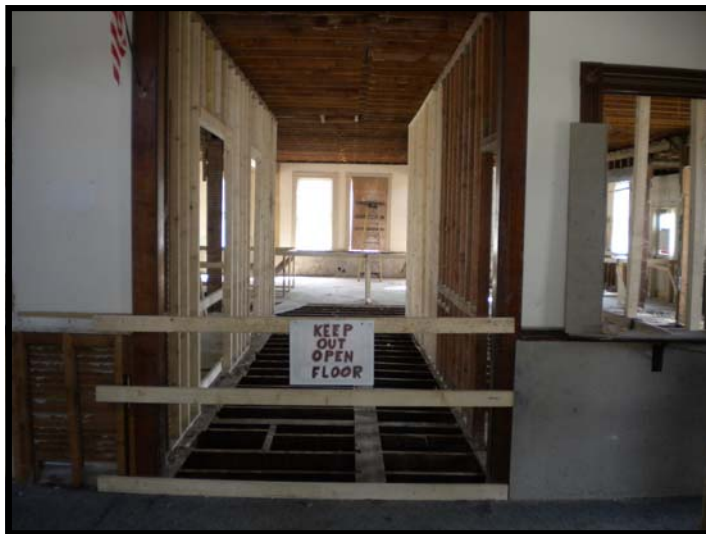
6

View of 1st floor hallway. (Area with flooring removed is approximate area of new staircase down to the ground level.)
