**Sluiceway and Tide Gate Structure
Green Harbor River
Marshfield, Massachusetts**

Inspection Report

**Massachusetts Office of Coastal Zone Management
Wetlands Restoration Program**

**The Louis Berger Group, Inc.
75 Second Avenue, Suite 700
Needham, MA 02494**

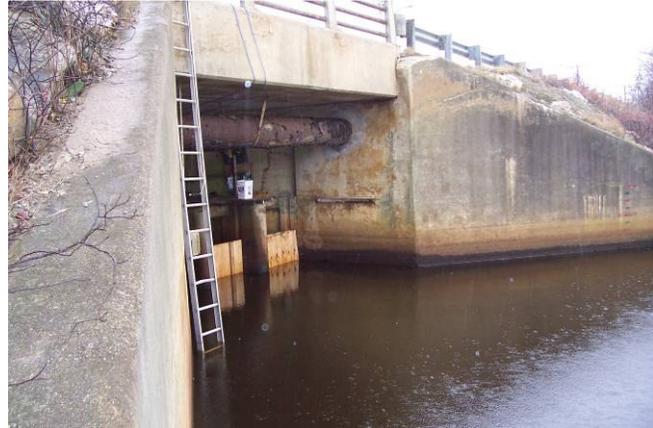
A waterline (*shown at right*) spans between the westerly walls (estuary side) of the sluiceway. The outer steel sleeve supporting this line is severely deteriorated with areas of complete section loss. As an interim measure, Offshore Marine has supported the waterline via strapping anchored to the concrete roof slab of the sluiceway.

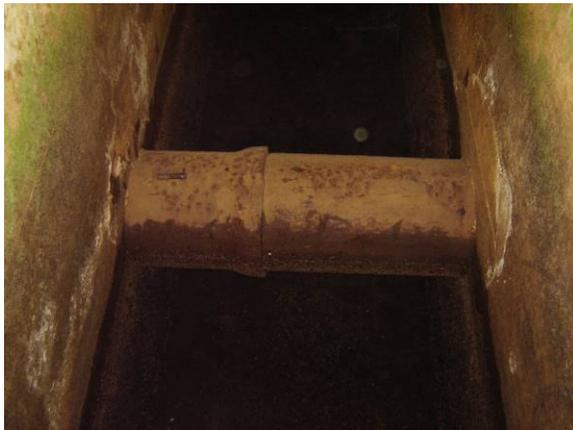
A 24" sewer line (*shown on left below*) spans between the northerly, center and southerly wall of the sluiceway, on the easterly side of the trash racks, and is located approximately 3 feet above the invert slab to the bottom of the sewer line.

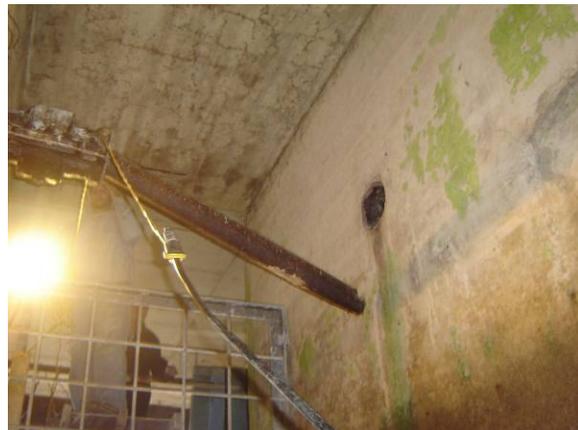
An abandoned, heavy rusted, 4" diameter steel conduit spans between the southerly and center walls, on the easterly side of the trash racks, approximately 12 feet above the invert slab and offset 3 feet west of the sewer line below. This conduit within the northern barrel of the sluiceway is broken and hanging from the center wall (*shown on right above*).

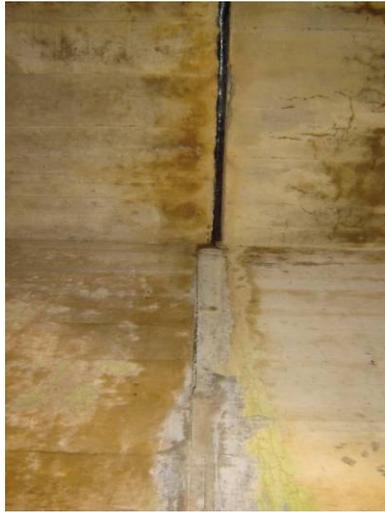
Commencing from the westerly end of the wall, an area of concrete abrasion and spalling was observed along the angled portion of the southerly wall between the sluice boards and trash racks. Only the lower 4 ½ feet of the wall (at and below the normal waterline) is abraded and spalled to an approximate depth of 3-4" with the exposed steel reinforcement exhibiting 100% section loss. Within various sections of the wall, previous attempts have been made to repair the concrete via patching. In all instances, it was found that the patch material has delaminated from

the substrate resulting in hollow sounding areas. These areas occur above and partially around the sewer line penetration through the wall, on either side of the vertical expansion joint, and in an area just before the angle point in the wall approaching the tide gates; approximately 6 feet above the invert slab. In addition, several fine to median cracks were observed particularly extending vertically from the patch area above the sewer line to the bottom of the roof slab. As mentioned above, the patching material has delaminated either side of the vertical expansion

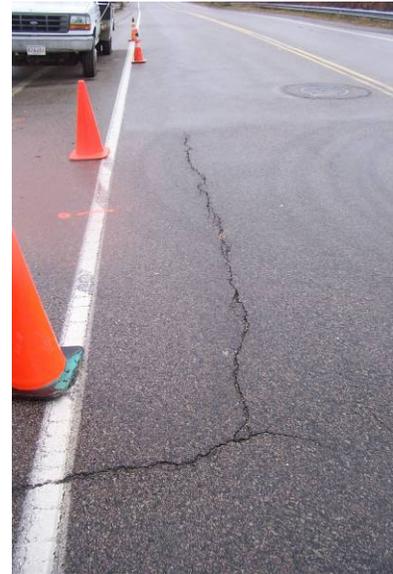
located in the wall. In addition, it appears that the construct joint has opened by approximately 3” at the bottom of the roof slab. As a result, what appears to be the waterproofing membrane, placed on the top of the roof slab, is clearly visible (*shown on left*). The opening of the expansion joint could be from the rotation or settlement of the easterly portion of the sluiceway structure in reference to the westerly section. Due to the very limited fill over the structure, the opening of the expansion joint has reflected through the roadway pavement above (*shown on right*).

As a result of the visual inspection performed, we believe that the existing structure possesses a sufficient remaining service life that modifications can be made to the existing tide gates, to increase the water exchange into the estuary, without having to perform major modifications or replacement of the existing structure. However, in order to maintain the service life of the structure it is recommended that areas of existing concrete spalls and cracks, including all previous concrete patching material that has become delaminated from its substrate, be repaired. In addition, periodic monitoring of the structure should be undertaken to ensure that no further movement or opening of the expansion joint is occurring.

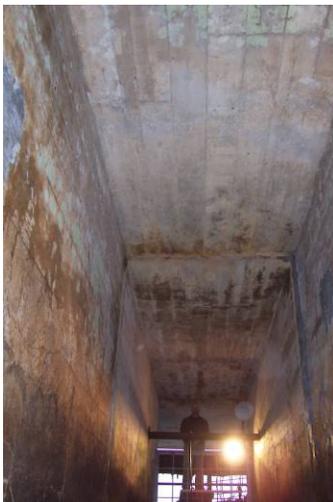
Though the roof slab was physically inaccessible due to its height above the invert slab, it appeared to be in generally good condition with no exposed reinforcing or visible concrete spalling (*shown on left below*). Minor areas of hair link cracking with moderate efflorescence were observed particularly above the ocean inlet area just west of the tide gates (*shown on right below*).

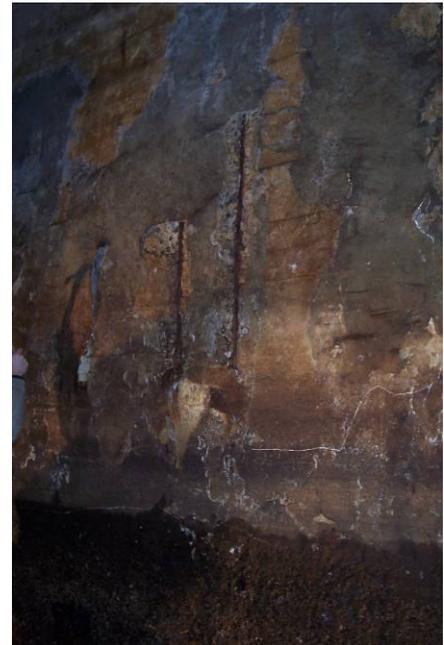
Similarly to the south wall, various sections of the center wall have been attempted to be repaired by patching the concrete. Again, in all areas it was found that the patch material has delaminated from the substrate below resulting in hollow sounding areas. These areas occur above and partially around the sewer line penetration through the center wall; on either side of the vertical expansion joint; and in a large area just before the angle point in the wall approaching the tide gates. This large area of de-lamination has areas of exposed and heavily rusted steel reinforcing with failed and flaking patch material (*shown at right*).

Again, over the entire length of the wall, from the normal water line to the top of the invert slab (approximately 4 feet) there is a heavy coating of barnacle and marine growth preventing a detailed visual inspection of the lower portion of the wall. In general, the south face of the center wall of the sluiceway is in fair to poor condition having experienced a higher state of deterioration than the south wall.

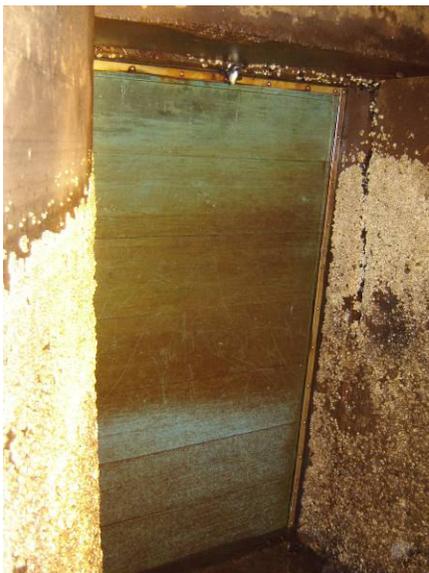
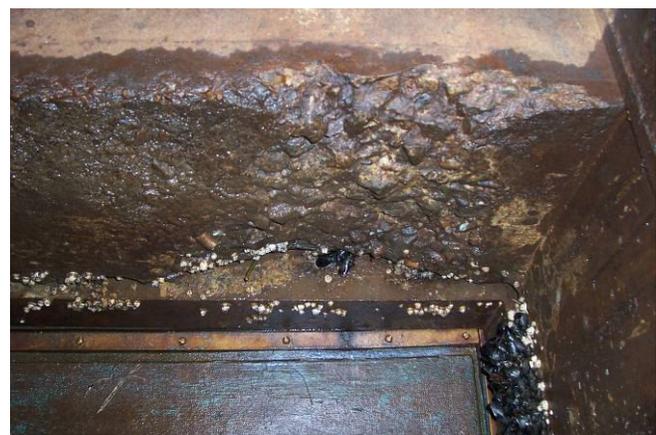
The back side of both tide gates in the south sluiceway barrel appeared in good condition with no visible signs of deterioration or distress. In limited areas, the concrete abutting the gate's steel frame has deteriorated resulting in the ability of water to leak through the joint between the concrete and the frame (*shown on right below*). At the time of the inspection, there was approximately 4 feet of head behind the tide gates (*shown on left below*).

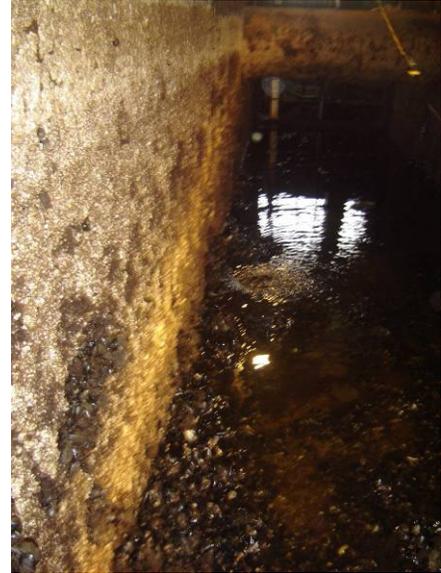
At the time of the inspection, approximately 4-5 inches of standing water was present within the sluiceway. In addition, the concrete invert slab was heavily coated with barnacle and marine growth preventing a detailed visual inspection. Water was observed to be piping up from the expansion joint within the invert slab at the face of the center wall (*shown on right*).

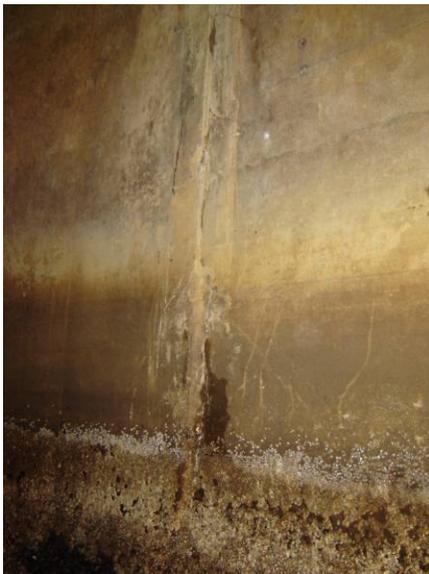
Over the entire length of the north wall, from the normal water line to the top of the invert slab (approximately 4 feet) there is a heavy coating of barnacle and marine growth which prevented a detailed visual inspection of the lower portion of the wall. The remaining exposed areas of the wall appeared in much better condition than the south sluiceway wall with only limited areas of delamination and cracking. A 1/16" crack was observed extending vertically from the sewer line penetration towards the roof slab as well as minor vertical cracking and efflorescence just before the tide gates. At the limited areas that have been previously patched, the patch material has delaminated resulting in hollow sounding areas. These occur on the angled portion of the northerly wall on the west side of the trash racks

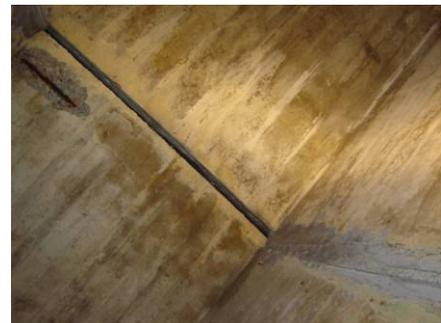
approximately 4'-6" above the invert slab and within the patch material either side of the vertical expansion joint. At this location, the patch material has lifted away from the wall. Similarly to the south wall, the vertical expansion joint has appeared to have opened up by approximately 3" at the bottom of the roof slab (*shown on right below*). However, unlike the south wall, the patch material filling the joint appears to be still bonded to the substrate (*shown on left*).

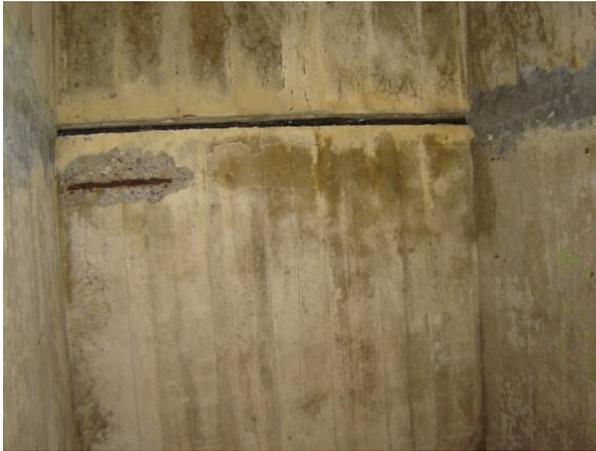
Though the roof slab was physically inaccessible due to its height above the invert slab, it appeared to be in generally good condition with only one area of exposed reinforcement near the expansion joint (*shown on left below*). Minor areas of hair link cracking with moderate efflorescence were observed particularly above the ocean inlet area just west of the tide gates (*shown on right below*).

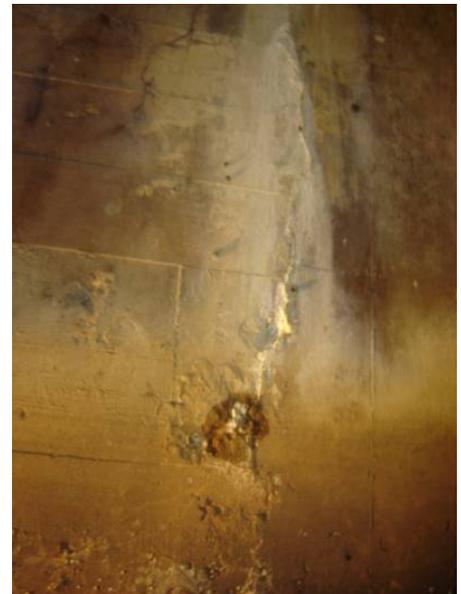
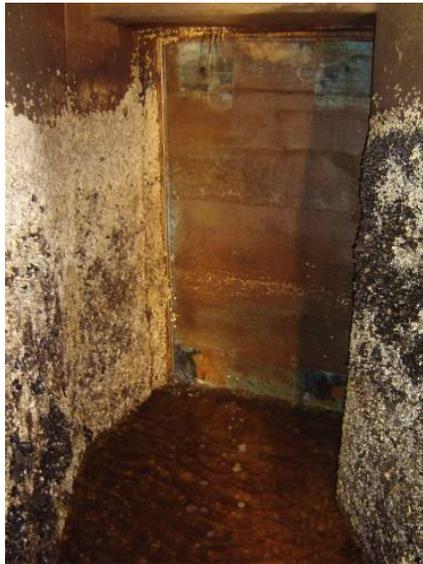
Over the entire length of the north face of the center wall, from the normal water line to the top of the invert slab (approximately 4 feet), there is a heavy coating of barnacle and marine growth preventing a detailed visual inspection of the lower portion of the wall. The remaining exposed areas of the wall appeared in much better condition than the south sluiceway wall with only limited areas of delamination and cracking. Two 1/8" wide cracks were observed extending vertically, one from the sewer line penetration towards the roof slab, and again approximately 4 ft from the angle point in the wall adjacent to the ocean inlet (*shown on right*). At the limited areas that have been previously patched, the patch material has delaminated resulting in hollow sounding areas. These occur on the 8 ft half height center wall adjacent to the estuary inlet; the vertical expansion joint; and in limited areas either side of the vertical crack previous noted near the ocean inlet.

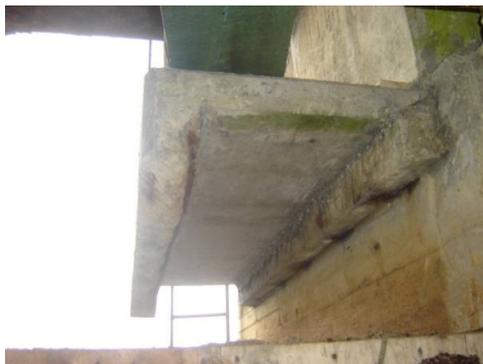
The concrete catwalk along the inside face of the northwest wingwall appeared in generally good condition with minor concrete spalling along its bottom edges (*shown on left below*).

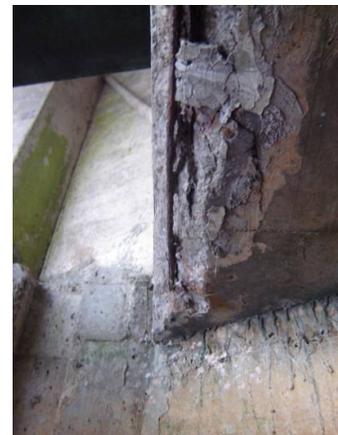
However, the catwalk extending perpendicular between the inside faces of the wingwalls had extensive areas of spalling concrete and exposed steel reinforcement (*shown on right below*).
