# Marshfield Beach Management Plan FINAL

Woods Hole Group, Inc.  
81 Technology Park Drive  
East Falmouth, MA 02536

**December 2017**

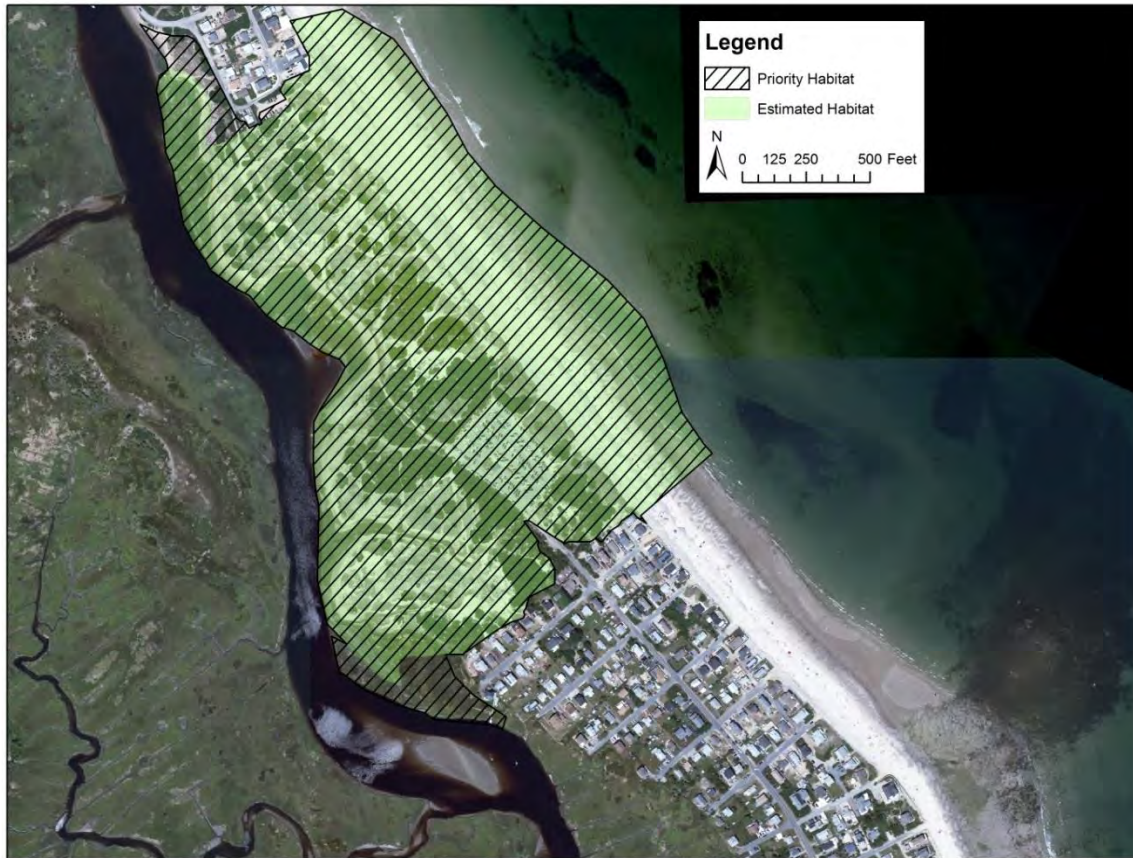
The Natural Heritage & Endangered Species Program (NHESP), part of the Massachusetts Division of Fisheries and Wildlife, is responsible for the conservation and protection of hundreds of species that are officially listed as Endangered, Threatened or of Special Concern in Massachusetts. At Rexhame Beach there are at least one species of bird protected by the NHESP: the Piping Plover (*Charadrius melodus*), which is considered Threatened federally, as well as in the state of Massachusetts. MassAudubon's Coastal Waterbird Monitoring Program has observed infrequent Piping Plover nest activity at the north end of Rexhame Beach, but none of the nesting attempts in the last 6 years have produced chicks. At least one species of rare or threatened plant is also present in the Rexhame dunes. To better protect and manage these species, the NHESP has developed and outlined areas of Priority Habitats, which are based on the known geographical extent of habitat for all state-listed rare species, both plants and animals. Priority Habitat mapped for the Rexhame Beach area is displayed in Figure 2-4. Estimated Habitats, another designation of NHESP that represent a sub-set of the Priority Habitats excluding areas specific only to plants, are also present at Rexhame Beach, and

encompass a slightly smaller area than the Priority Habitat areas. Given the potential for impacts to state-listed species, any work planned for the Rexhame area should involve a consultation with NHESP prior to the finalization of plans.

**Figure 2-4. Natural Heritage and Endangered Species Program Estimated and Priority Habitat at Rexhame Beach.**

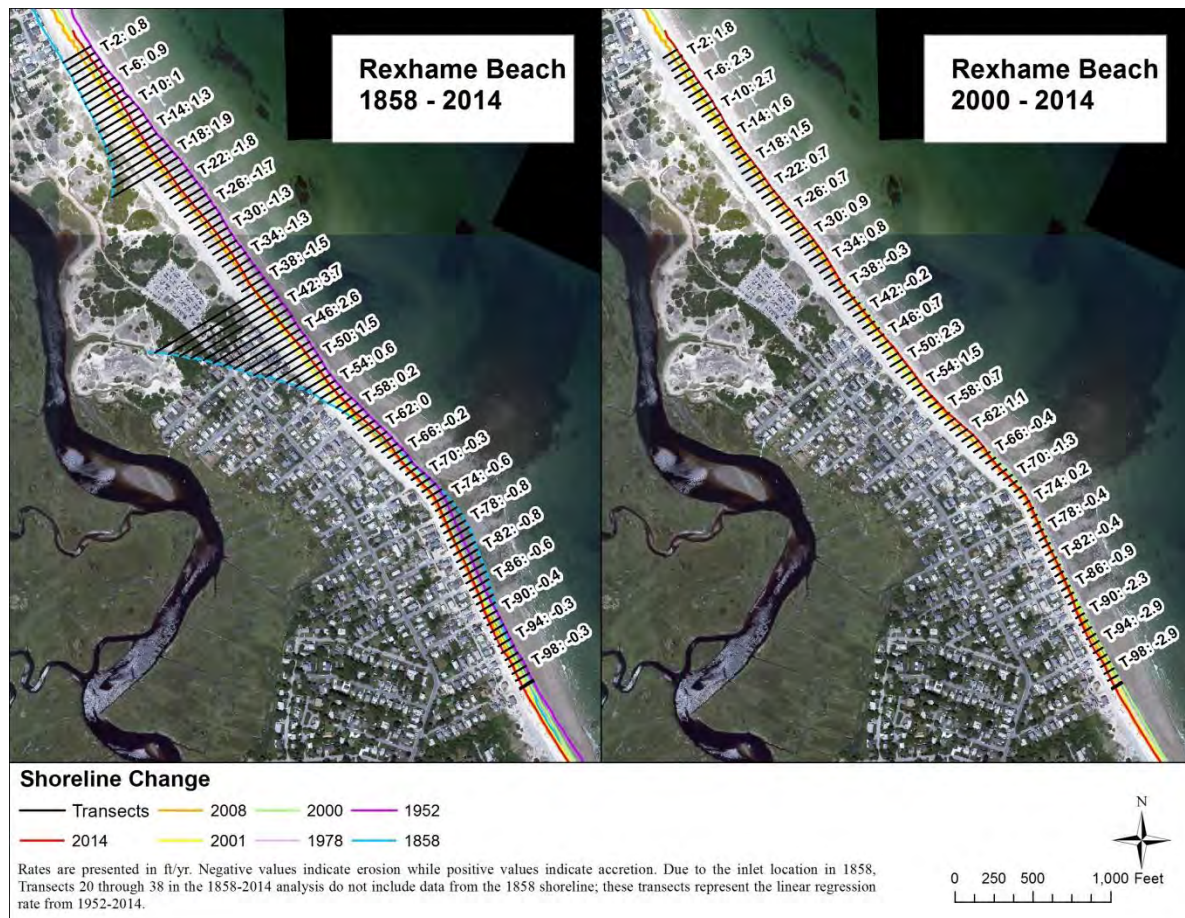
**Figure 2-5. Long- and short-term shoreline change rates for Rexhame Beach.**

The long-term (1858-2014) average rate of change for the entire Rexhame Beach study area was 0.2 ft/yr, indicating a fairly stable beach. However, this long-term rate is largely influenced by the 1858 shoreline; in 1858 there was an inlet in this location. If only the portion of Rexhame Beach fronting the parking lot and immediately to the north (where there is no 1858 shoreline because this was the location of the inlet) was considered, the 1952 to 2014 shoreline change rate averages to -1.5 ft/yr. This rate is more indicative of the changes observed at Rexhame Beach since it has been used as a major public recreation location. The short-term (2000-2014) average rate of change for the whole study area was 0.2 ft/yr, just like the long term. Again, this would indicate a fairly stable beach. However, it is worth considering different regions of the study area separately, however. For example, from Transect 66 south, the recent trend has been erosional, with an average rate of change for this portion of the beach of -1.4 ft/yr, which may have prompted the various shoreline stabilization projects between Parker and Porter Street (Figure 2-6 & Figure 2-7). The same area fronting the parking lot and immediately to the north (Transects 20 to 38) has an average shoreline change rate of 0.6 ft/yr. This rate reflects the three beach nourishment projects that have occurred in this location. 1,500 cubic yards of sand was placed on the beach in 2007, 800 cubic yards in 2013 and 3,000 cubic yards in 2016.

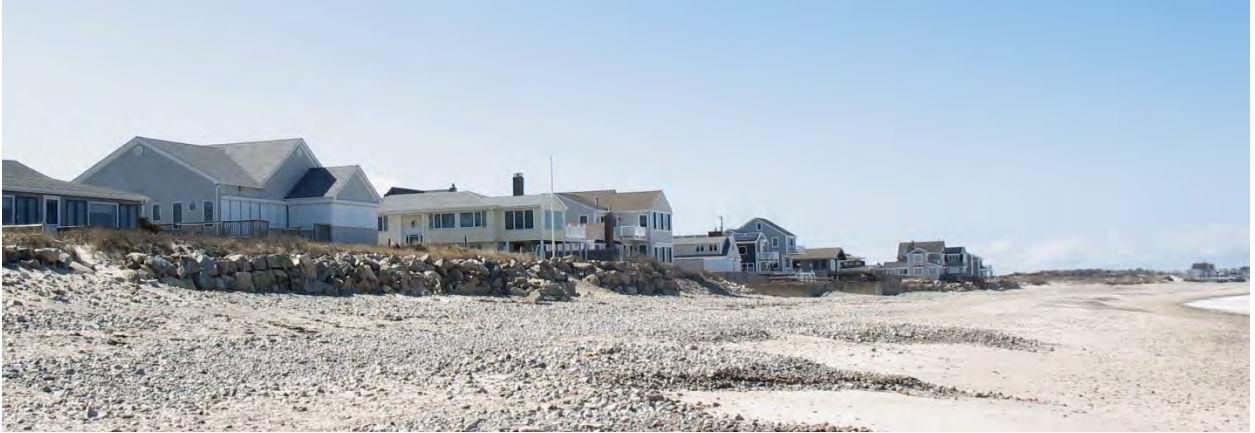
**Figure 2-6. Various shoreline stabilization structures protect private houses between Parker Street and Porter Street.**

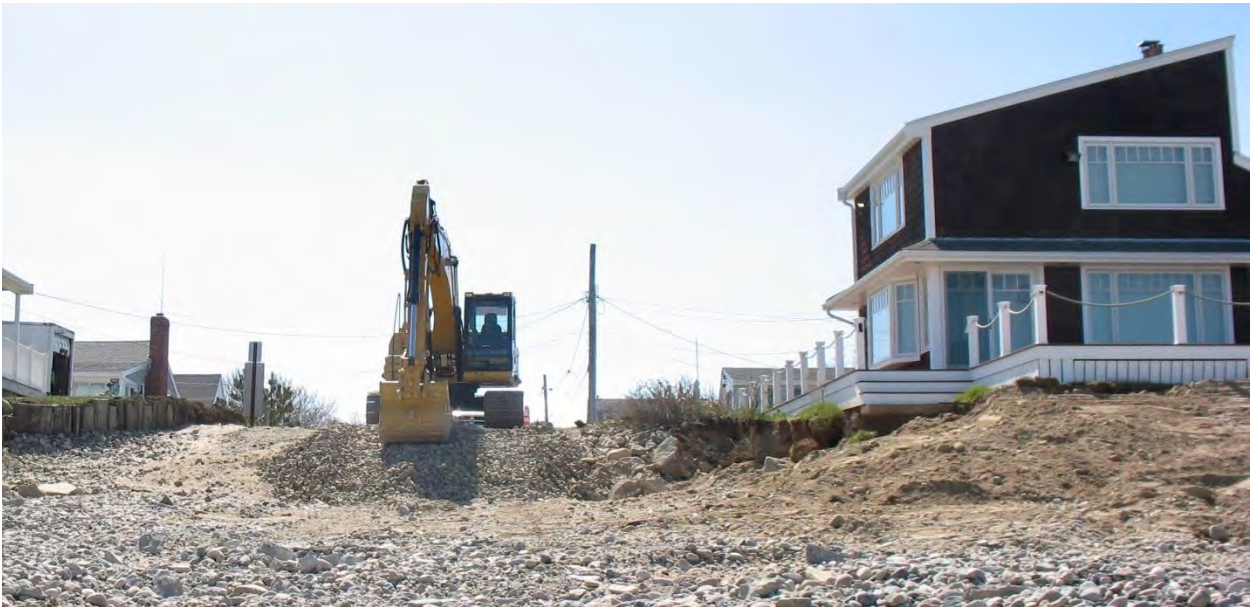
**Figure 2-7. Bank stabilization project underway at the end of Minot Road.**

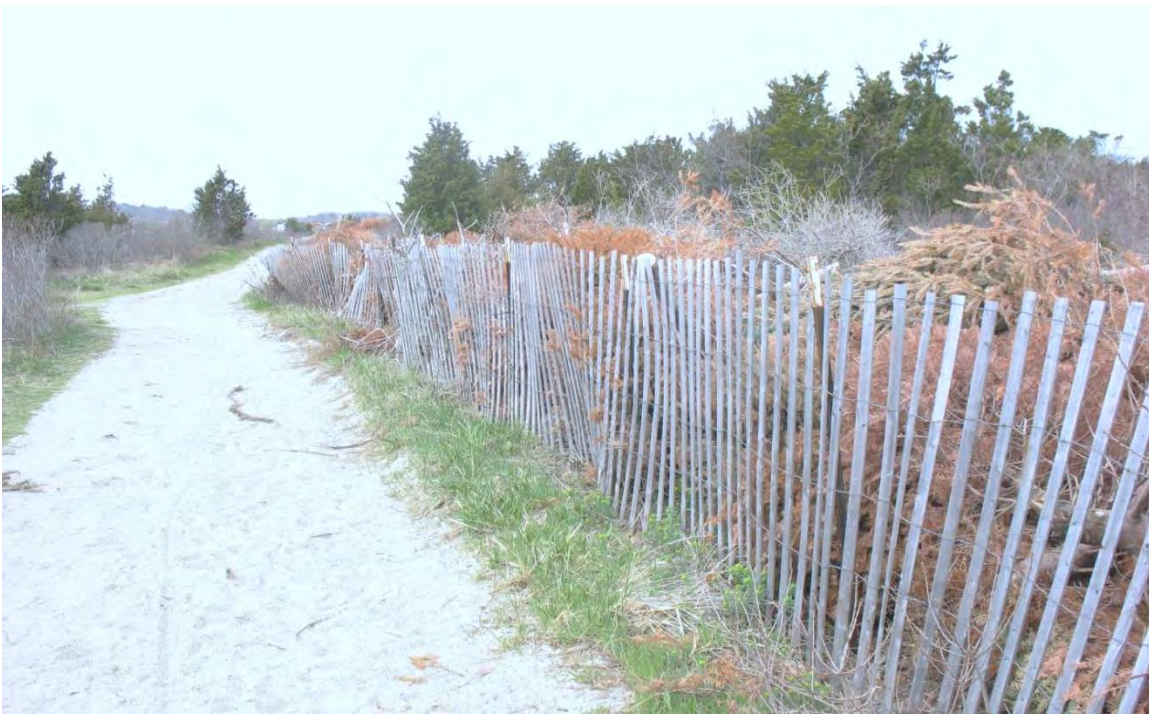
**Figure 2-10. Sand fencing and piled Christmas trees to deter visitors from walking through the dunes.**

From the parking lot, there are three sand paths that cross over the Coastal Dune to access the Coastal Beach. These paths are delineated with sand fencing to deter visitors from walking through the rest of the dunes, but the fencing is in need of repair. Sand fencing is also placed on the seaward side of the dunes to help trap sand, but this line of fencing is currently situated approximately 10 to 15 feet back from the seaward toe of the dune. The coastal beach is a mix of sand and cobbles, and a dry beach is present at all tides. Seaweed can occasionally accumulate on this beach, but it is often manageable simply by hand raking it to spread it out so it can be washed away. Mechanical seaweed removal has not been required at this location for approximately 12 years.

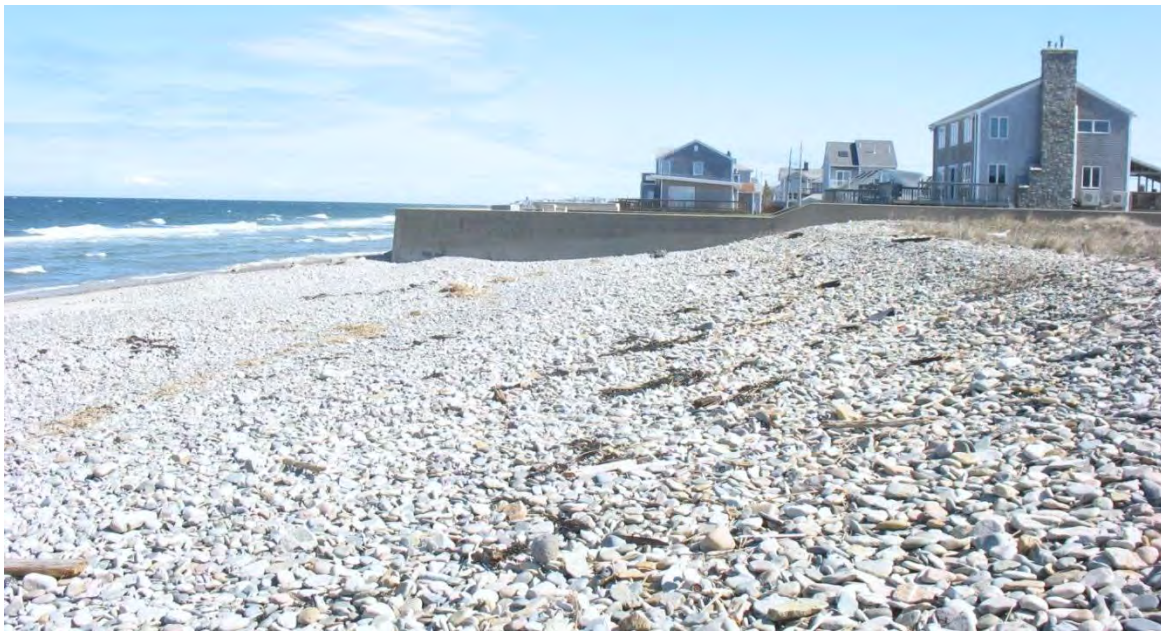
**Figure 2-11. Cobble beach and cobble berm at Winslow Avenue Beach.**

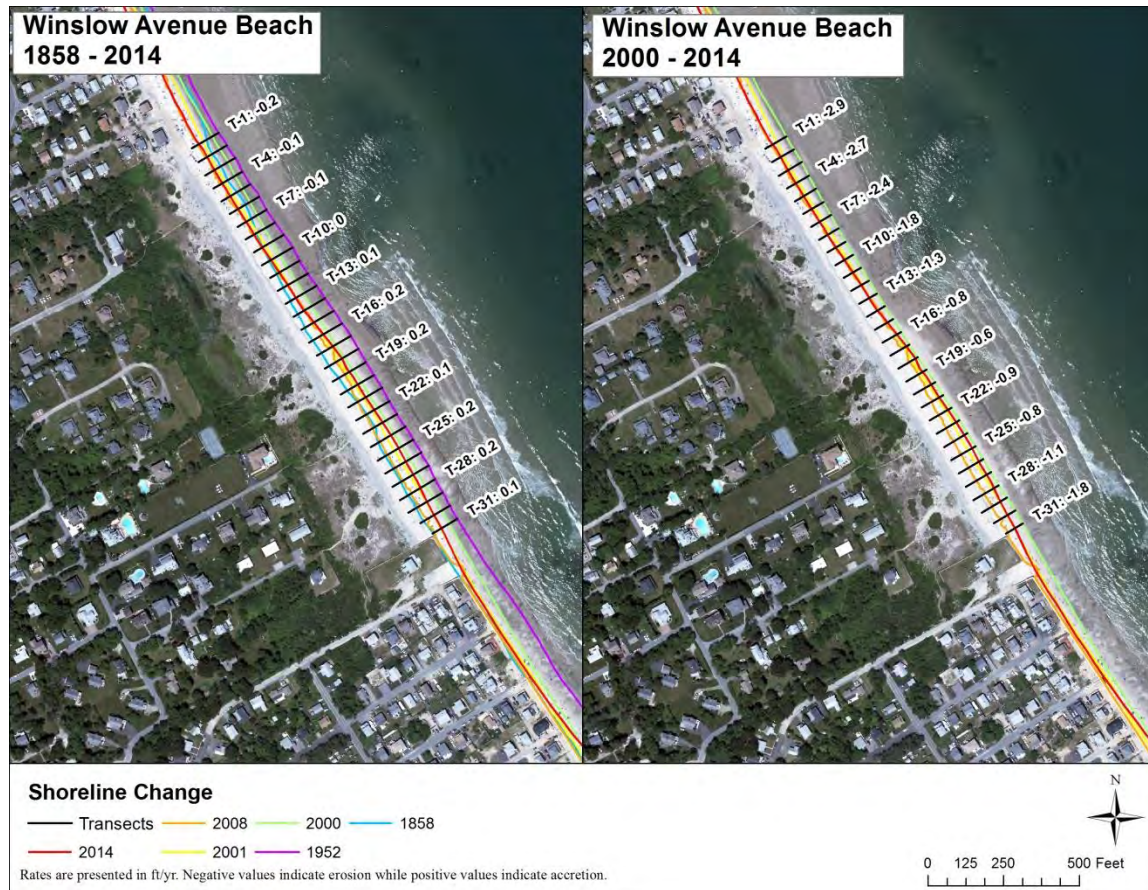
**Figure 2-13. Long- and short-term shoreline change rates for Winslow Avenue Beach.**

The long-term (1858-2014) average rate of change for the entire Winslow Avenue Beach study area was 0.1 ft/yr, indicating a stable beach, which is reflected in the fact that this portion of the shoreline has not required armoring, and may also be due to the increased stability provided by the cobble beach and cobble berm present at this location. The short-term (2000-2014) average rate of change was -1.5 ft/yr. This rate seems to be largely driven by the change between 2000 and 2008, while the changes between 2008 and 2014 appear to be largely accretional. The challenges with identifying a high water line on a beach with this unique sediment type (cobble rather than sand) may have added to the potential error in defining shoreline change rates for this location.

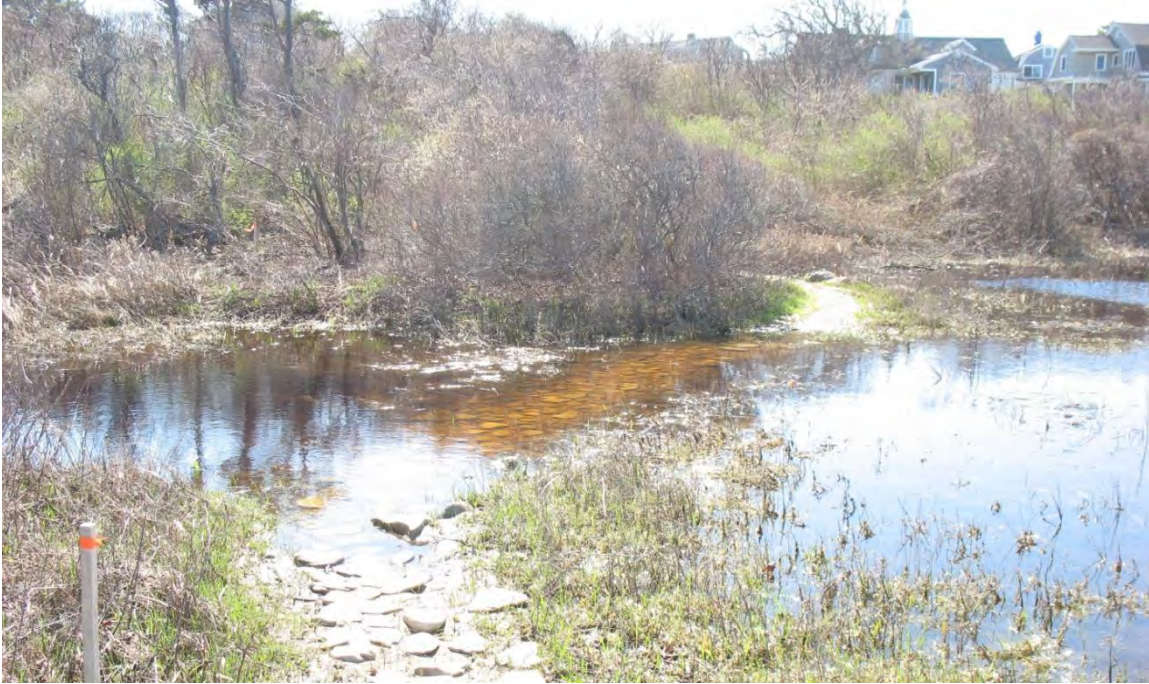
**Figure 2-15. Flooded low point on the public access trail to Winslow Avenue Beach.**

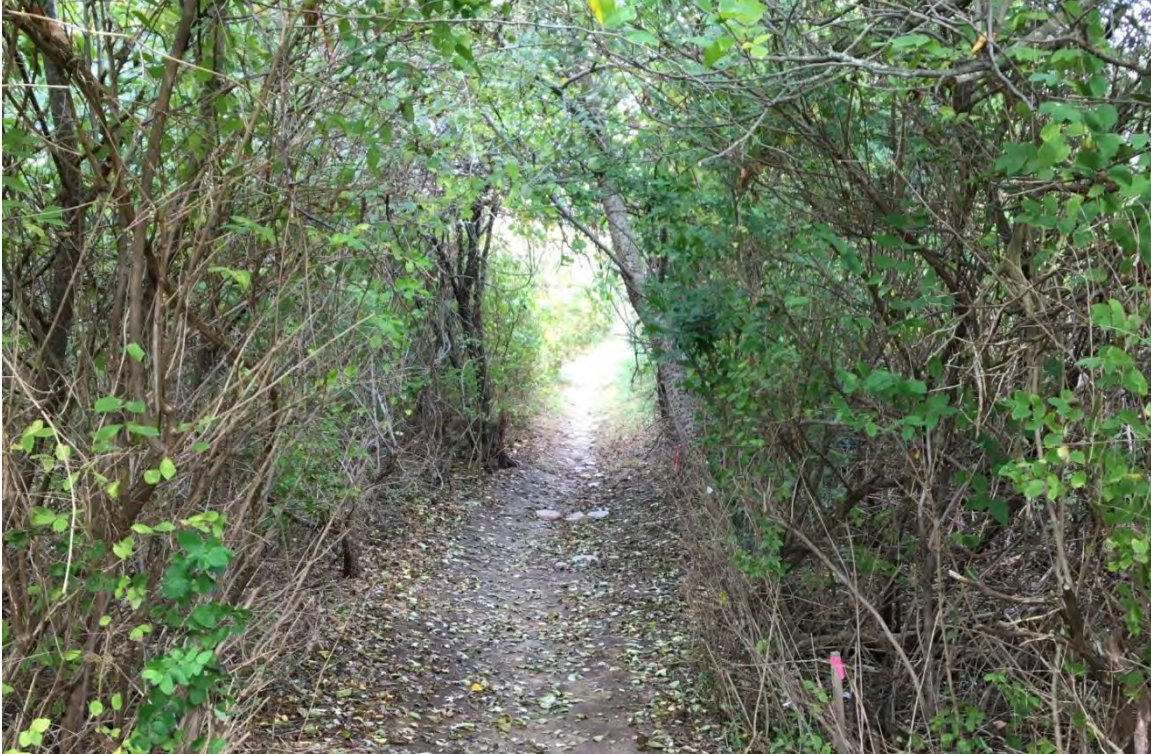
There are five footpaths through the Coastal Dune that provide pedestrian access to the beach, but only one of these access ways is public; the public right of way to the beach begins at the seaward end of Winslow Avenue. This unimproved trail is approximately 500 feet long (Figure 2-16), and is predominately used by the nearby residents since there is no public parking at Winslow Avenue Beach. As mentioned above, this trail occasionally floods when the adjacent wetland is inundated, and access can be interrupted. Additionally, because there is no public parking, the Town of Marshfield does not currently collect any beach fees from people who utilize Winslow Avenue Beach. There are also no restrooms, life guards or other amenities at this beach.

**Figure 2-16. Winslow Avenue Beach right of way.**

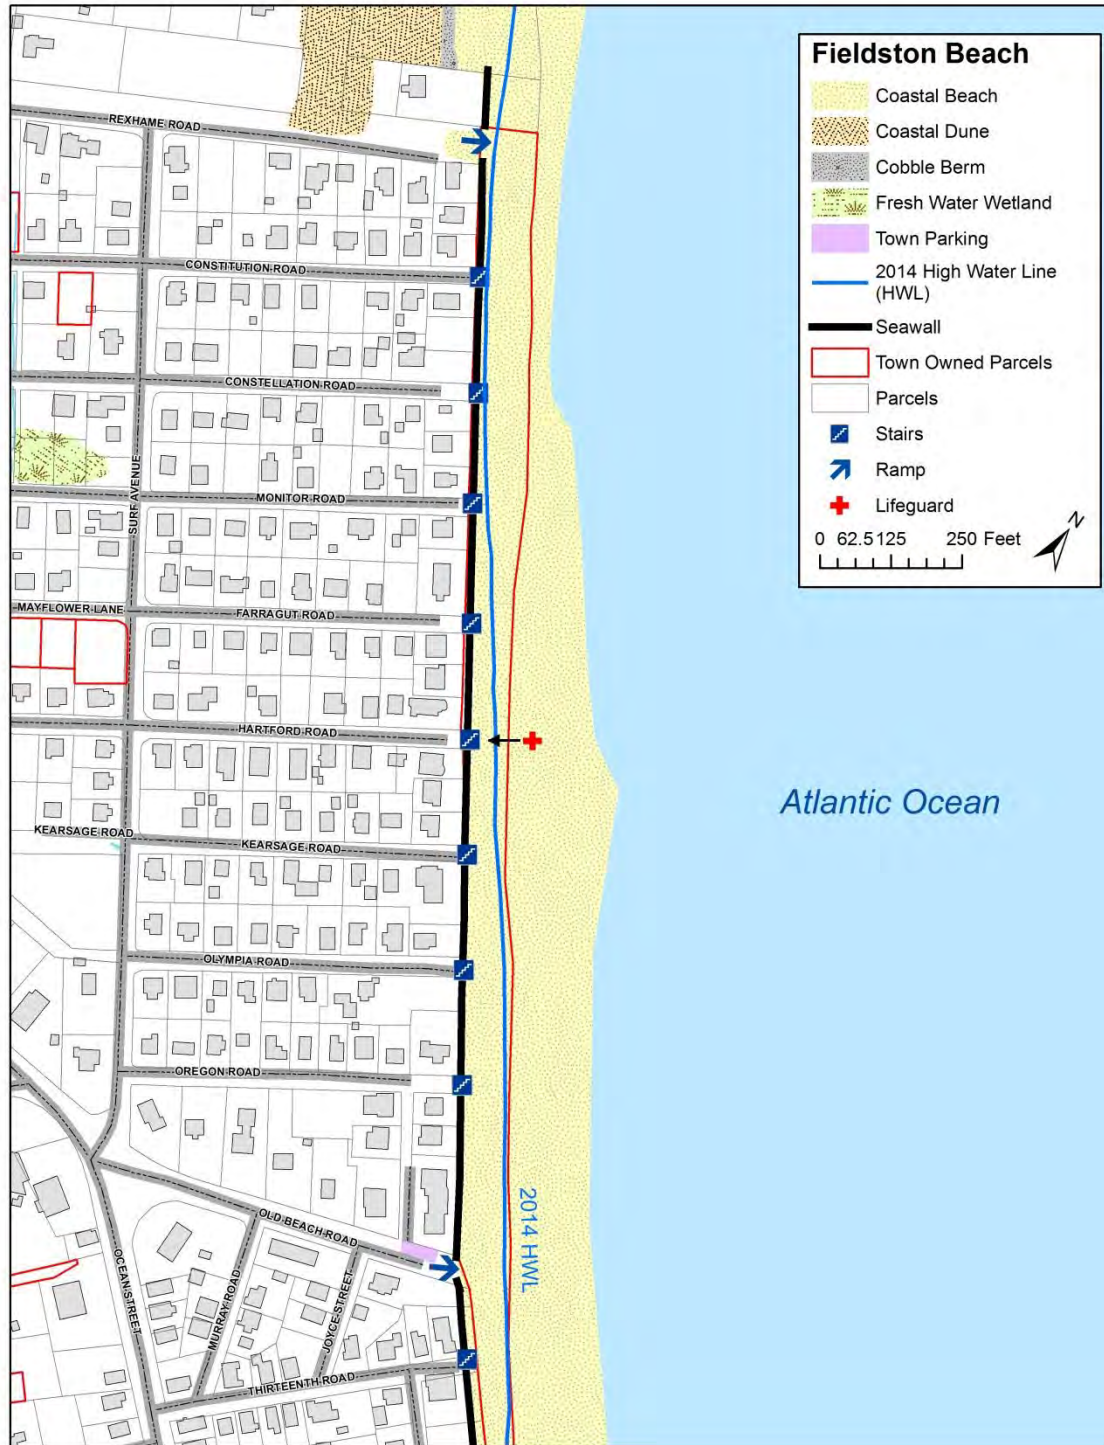
Figure 2-17. Fieldston Beach existing conditions.

Fieldston Beach is located along the shoreline of Marshfield, south of Winslow Avenue Beach, extending approximately from Rexhame Road to Old Beach Road (Figure 2-17). Public parking is limited to a small lot at the end of Old Beach Road, but there are public access points at the seaward end of all the side streets. Fieldston Beach includes approximately 2,000 linear feet of ocean facing shoreline.

The entirety of the unimproved section of the Fieldston Beach parcels is classified as Coastal Beach and Land Under the Ocean, Ponds, Rivers, Lakes. There is no Coastal Dune present along the stretch of coastline and no vegetation fronting the concrete seawall and stone revetments. The high tide beach along Fieldston Beach varies from narrow but present at the southern end near the Oregon Road access, to completely absent at the northern end near the Constitution Road access. Most of the beach is sand with large deposits of cobble (Figure 2-18). Grain size analysis (Appendix C) from a sample taken from the intertidal area in the vicinity of the small parking area at the end of Ocean Beach Road indicated that the sediment at Fieldston and Sunrise Beaches is largely sand (93.9%), with 5.4% gravel, and 0.7% fines (i.e., silt or clay); note that one grain size sample was taken to represent both Fieldston and Sunrises Beaches. There are no NHESP mapped Estimated or Priority Habitat areas at Fieldston Beach.

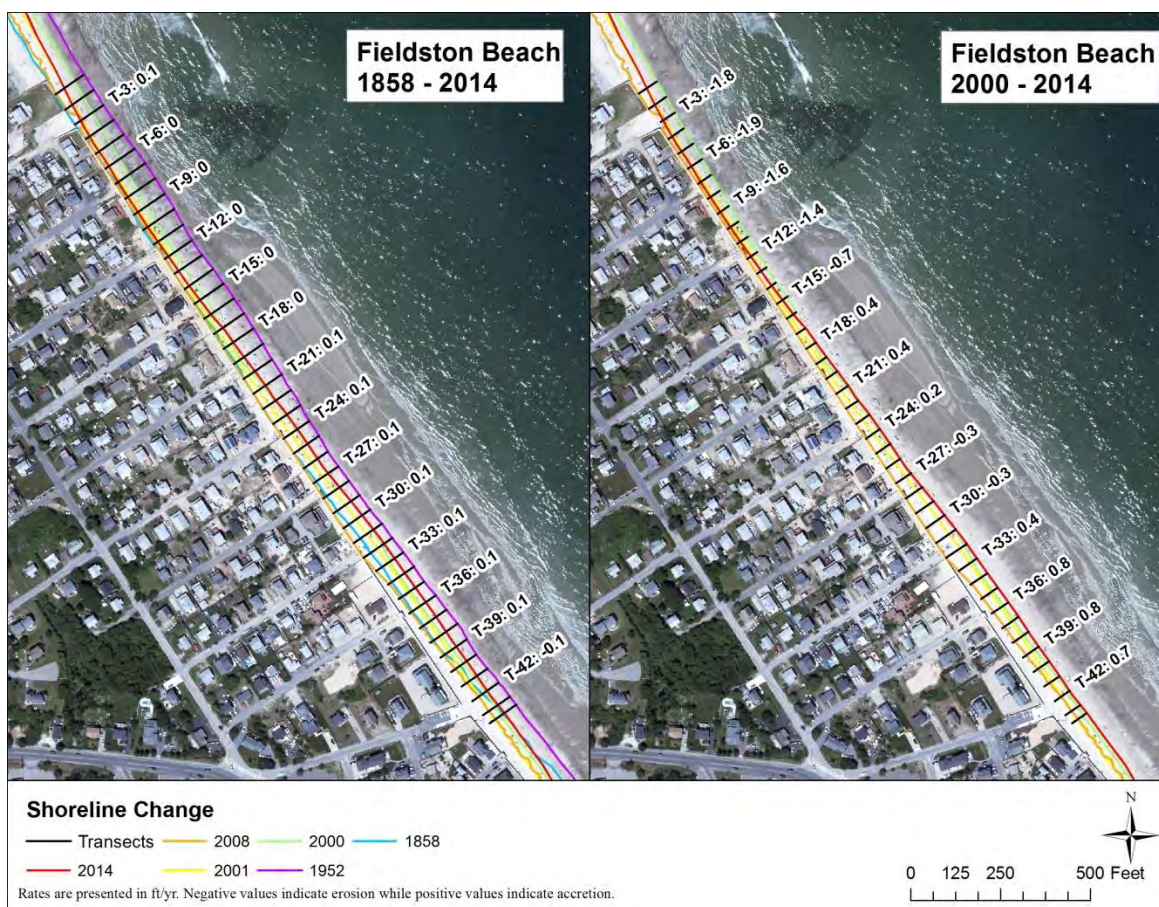
**Figure 2-19. Long- and short-term shoreline change rates for Fieldston Beach.**

slightly erosional, but that is largely due to the presence of a concrete seawall for the entire length of the analysis area at Fieldston Beach. This seawall was originally constructed during the 1930s by the Commonwealth of Massachusetts, and has prevented any further retreat of the shoreline. With the exception of the 1858 shoreline, this means the long-term shoreline change analysis timeframe for this area has been influenced by that seawall. There is little to no dry high tide beach in this section of town, which means that additional horizontal erosion cannot occur. Vertical erosion, which must be measured through targeted low-tide LiDAR data or through field topographic surveys, can and likely will continue to occur. If the beach profile is lowered enough, the stability and integrity of the seawalls will be threatened.

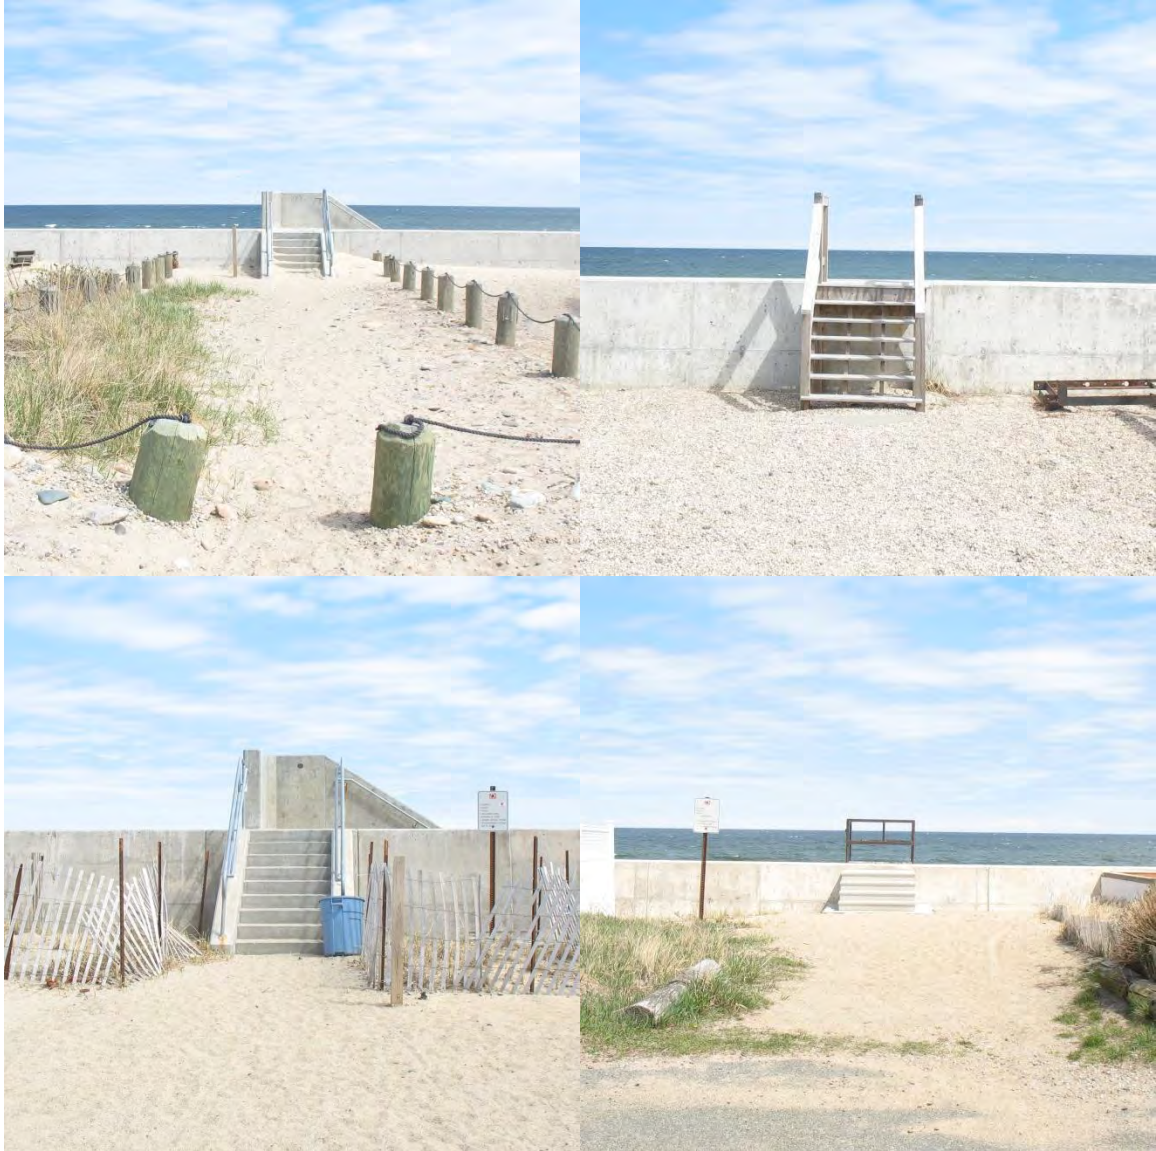
In addition to the small parking lot at the end of Old Beach Road, there are nine (9) additional access points to Fieldston Beach from the ends of the side roads off Surf Ave (Figure 2-20).

The ramp at the end of Rexhame Road is not barricaded in the winter, and the tide regularly overflows onto the road. During the summer, there is a lifeguard station set up on the concrete pad at the top of the stairs at the end of Hartford Road (roughly at the center point of the beach area). There are no public restrooms or other amenities at this beach.

**Figure 2-20. Beach access locations at Oregon Road (top left), Olympia Road (top right), Constellation Road (bottom left) and Constitution Road (bottom right).**

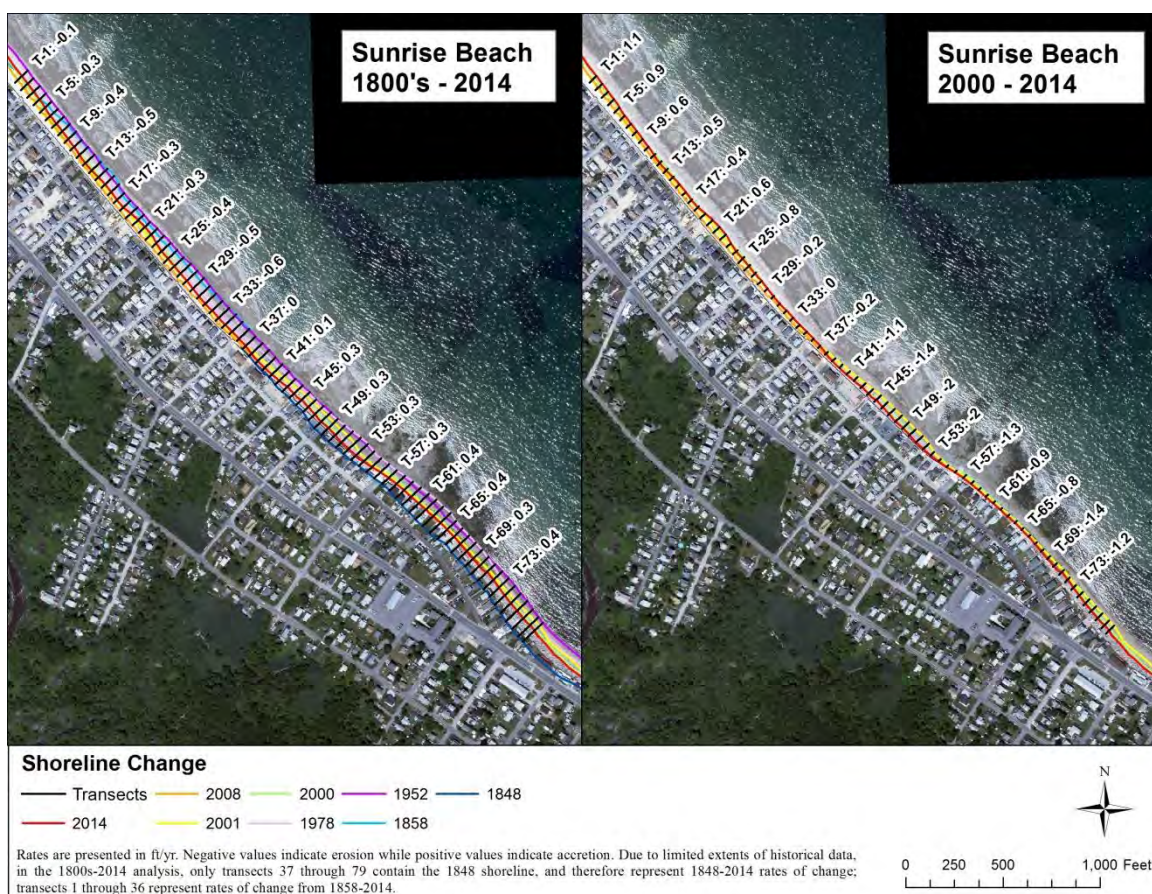
**Figure 2-21. Long- and short- term shoreline change for Sunrise Beach.**

The long-term (1848/1958-2014) average rate of change for the entire Sunrise Beach study area was 0.0 ft/yr, indicating a stable beach. The short-term (2000-2014) average rate of change was -0.7 ft/yr, indicating a slight erosional trend. There appears to be a point around Transect 36 (approximately between Fourth and Fifth Roads), where north of this point the beach is stable to slightly accretional (average 2000-2014 shoreline change rate of 0.1 ft/yr), while the area south of this point is erosional (average 2000-2014 shoreline change rate of -1.4 ft/yr). Like Fieldston Beach, Sunrise Beach is entirely backed by a concrete seawall that originally constructed during the 1930s by the Commonwealth of Massachusetts. The shoreline retreat rates observed in the southern portion of the beach will not continue indefinitely. Given that there is currently little to no dry high tide beach, it is likely that the seawall will prevent any further horizontal retreat of the shoreline in this area. Vertical erosion, which must be measured through targeted low-tide LiDAR data or through field topographic surveys, can and likely will continue. If the beach profile is lowered enough, the stability of the seawalls will be threatened.

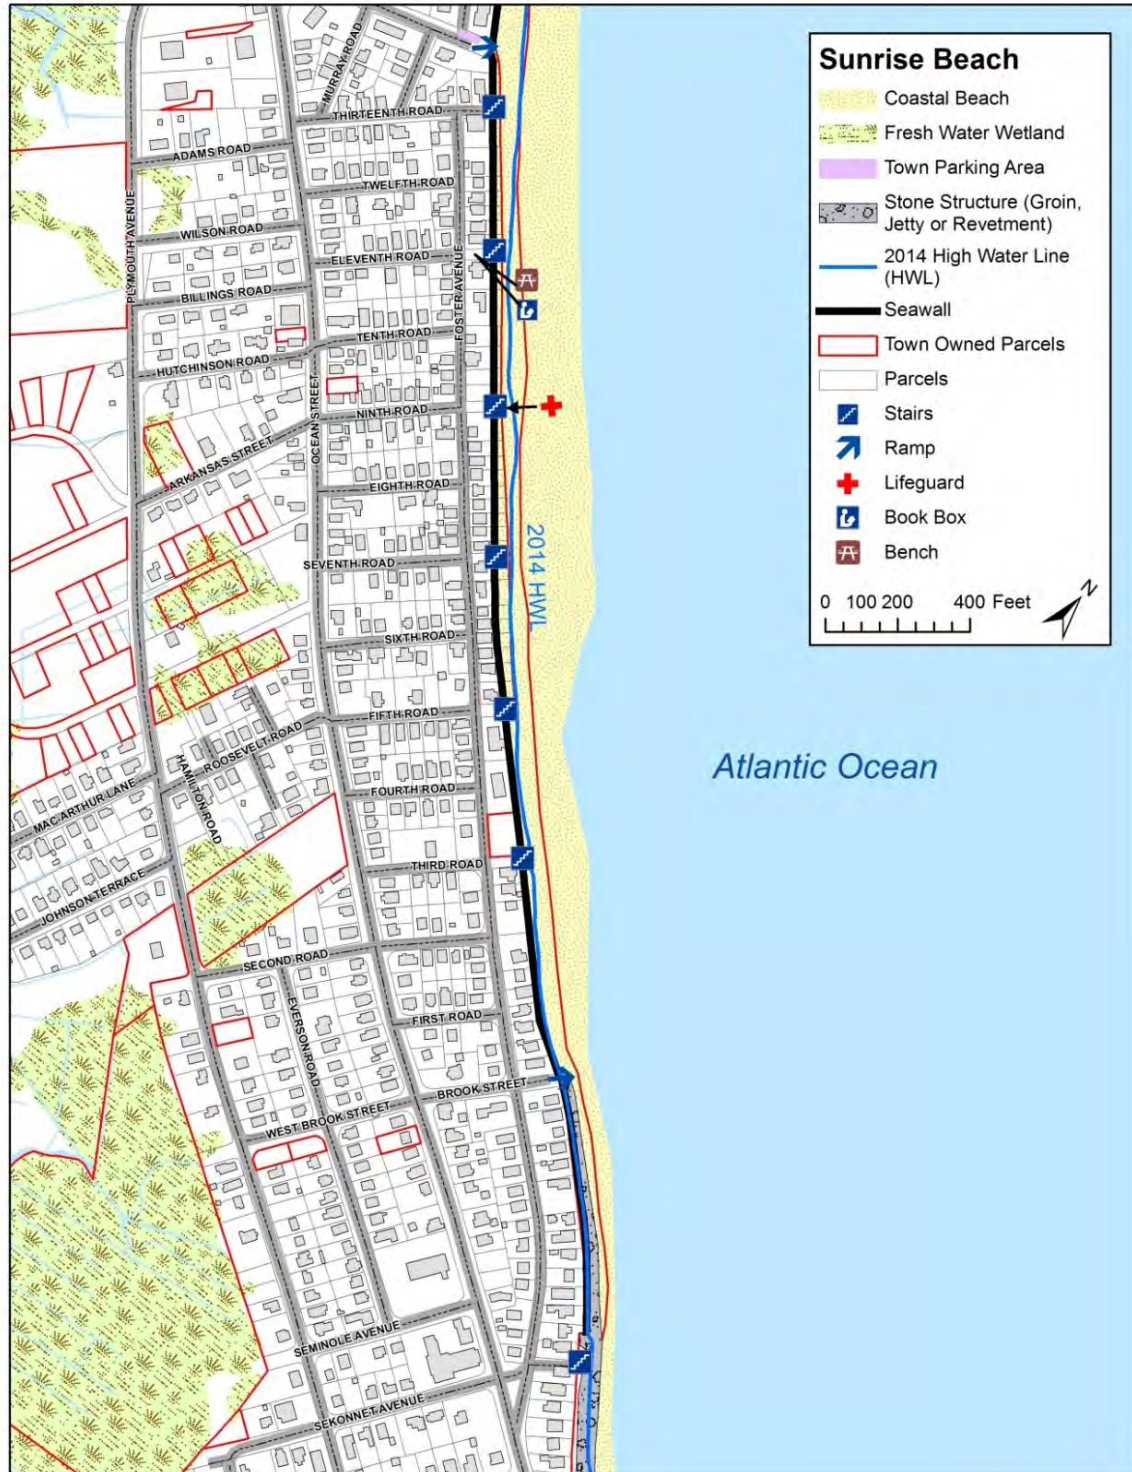
Figure 2-22. Sunrise Beach existing conditions.

Sunrise Beach is located along the shoreline of Marshfield, south of Fieldston Beach, extending approximately from Old Beach Road to the southern end of Foster Avenue (Figure 2-22). Although there is no public parking, there are public access points at the seaward end of all odd-numbered side streets between 3<sup>rd</sup> Road and 13<sup>th</sup> Road, as well as the Brook Street and Shephard's Avenue access ways. Sunrise Beach includes approximately 3,700 linear feet of ocean facing shoreline.

Like Fieldston Beach, the entire length of Sunrise Beach is fronted by a continuous concrete seawall. The northern stretch of concrete seawall, down to the 9<sup>th</sup> Street Access was recently repaired and increased in height. The southeastern portion of the beach, from the 5<sup>th</sup> Street Access south, also has a rock revetment fronting the concrete seawall. The 5<sup>th</sup> Street Access also roughly divides the sandier beach to the north and the rockier beach to the south. Much of Sunrise Beach has no dry beach at high tide.

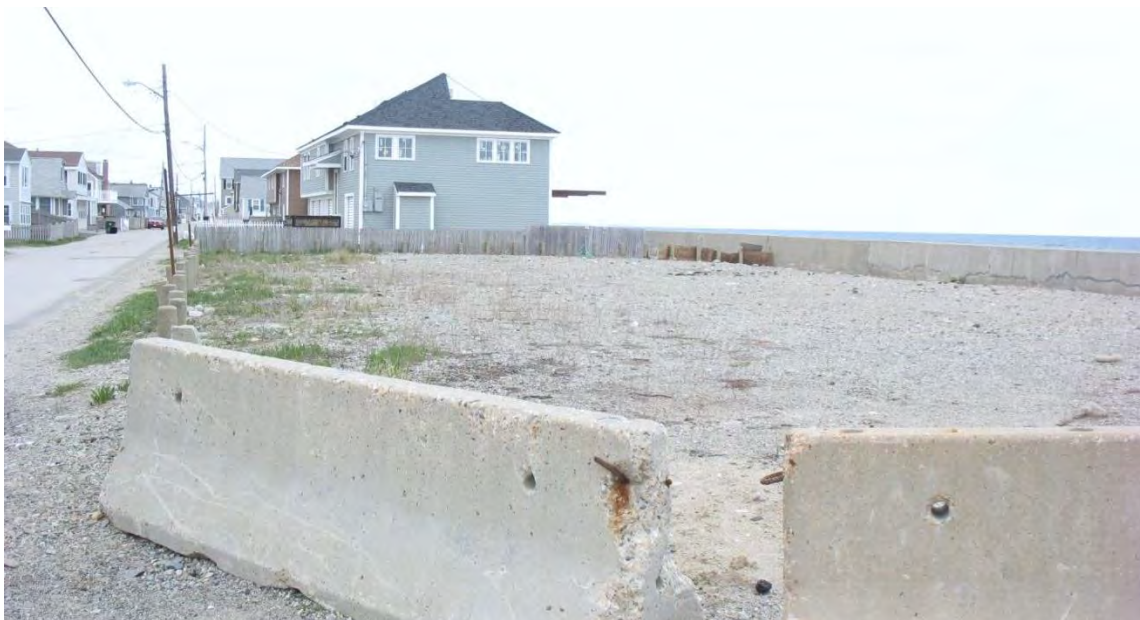
The stairs at the Shepard's Ave Access point frequently get damaged in the winter and must be repaired or replaced. All access points have a paved path leading to the stairway, and many of the pathways have been lined with painted rocks placed by visitors. The vacant lot to the north of the 3<sup>rd</sup> Street Access is owned by the Town and could be used as a location for additional beach amenities (Figure 2-24). There is also a vacant lot to the north of the 9<sup>th</sup> Street Access (not currently owned by the Town). The 9<sup>th</sup> and 11<sup>th</sup> Street Access locations are the most developed, with a landscaped buffer along the path; the 11<sup>th</sup> Street Access also contains a bench and a book box. The concrete platform at the 9<sup>th</sup> Street Access is also where the lifeguard station is located during the summer.

**Figure 2-24. Vacant lot north of the 3rd Street beach access.**

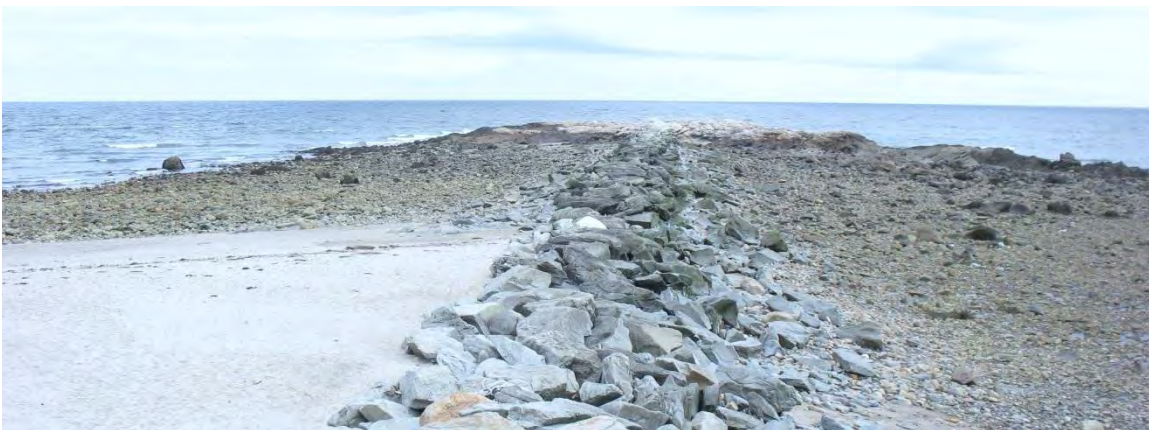
**Figure 2-26. Rocky intertidal shore around the Brant Rock groin.**

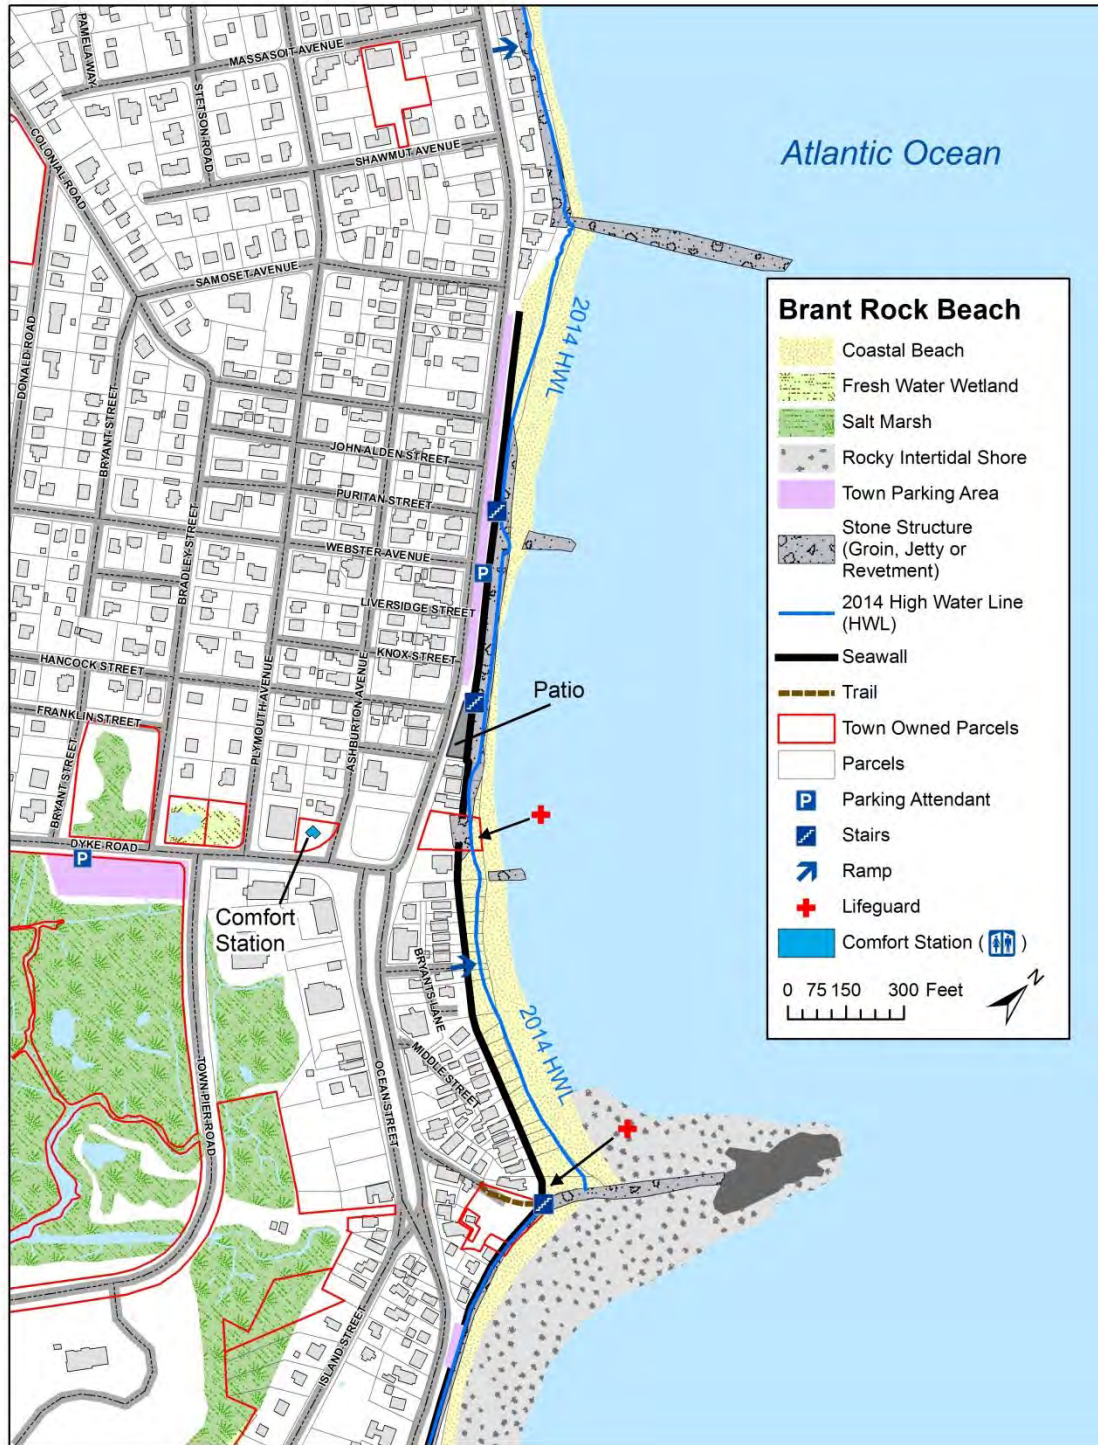
Figure 2-27. Brant Rock Beach existing conditions.

Brant Rock Beach is located in the vicinity of the Esplanade and can be accessed from Ocean Street (Figure 2-27). The main points of access are from the public access ways at the ends of South and North Streets, as well as from the staircase located directly adjacent to Ocean Street. Brant Rock Beach has a unique rocky feature at the seaward end of the groin at the southern end of the beach. The Town owned portion of Brant Rock Beach extends from small ocean front parking area at the top of the hill on Ocean Street north to Sunrise Beach. Brant Rock Beach includes approximately 5,000 linear feet of ocean facing shoreline.

The long-term (1848-2014) average rate of change for the entire Brant Rock Beach study area was 0.2 ft/yr. Similarly, the short-term (2000-2014) average rate of change for the entire study area was -0.2 ft/yr. Both indicate a fairly stable beach. This is likely due to the presence of a concrete seawall for the entire length of the analysis area at Brant Rock Beach. This seawall was originally constructed during the 1930s by the Commonwealth of Massachusetts, and has prevented any further retreat of the shoreline. With the exception of the 1858 shoreline, this means the long-term shoreline change analysis timeframe for this area has been influenced by that seawall. There is little to no dry high tide beach along this stretch of coastline, with the exception of the area immediately north of the large Brant Rock groin, which means that additional horizontal erosion cannot occur. Vertical erosion, which must be measured through targeted low-tide LiDAR data or through field topographic surveys, can and likely will continue to occur. If the beach profile is lowered enough, the stability and integrity of the seawalls will be threatened. The area immediately north of the groin, Transects 46-53, has experience accretion at a rate of 0.9 ft/yr since 2000. This is due to sediment carried on the southerly long-shore current that gets trapped and collected against the shore perpendicular structure.

Like some of the other Marshfield Beach, the entire length of Brant Rock Beach is armored in some way. From Samoset Avenue to the south, the beach is backed by a continuous concrete seawall, much of which is currently in need of repairs. The Town has plans to repair and increase the height of the seawall between North Street and Dyke Road. In many places this seawall is also fronted by a rock revetment: from Puritan Street to Dyke Road and from the large groin at South Street to the south. North of Samoset Avenue, there are private homes fronting the beach, which all have individual but connected coastal armoring, consisting mainly of concrete seawalls fronted by a wide rock revetment. There are also four rock groins at Brant Rock Beach: one approximately 675 feet long between Shawmut Ave and Samoset Ave, one approximately 150 feet long

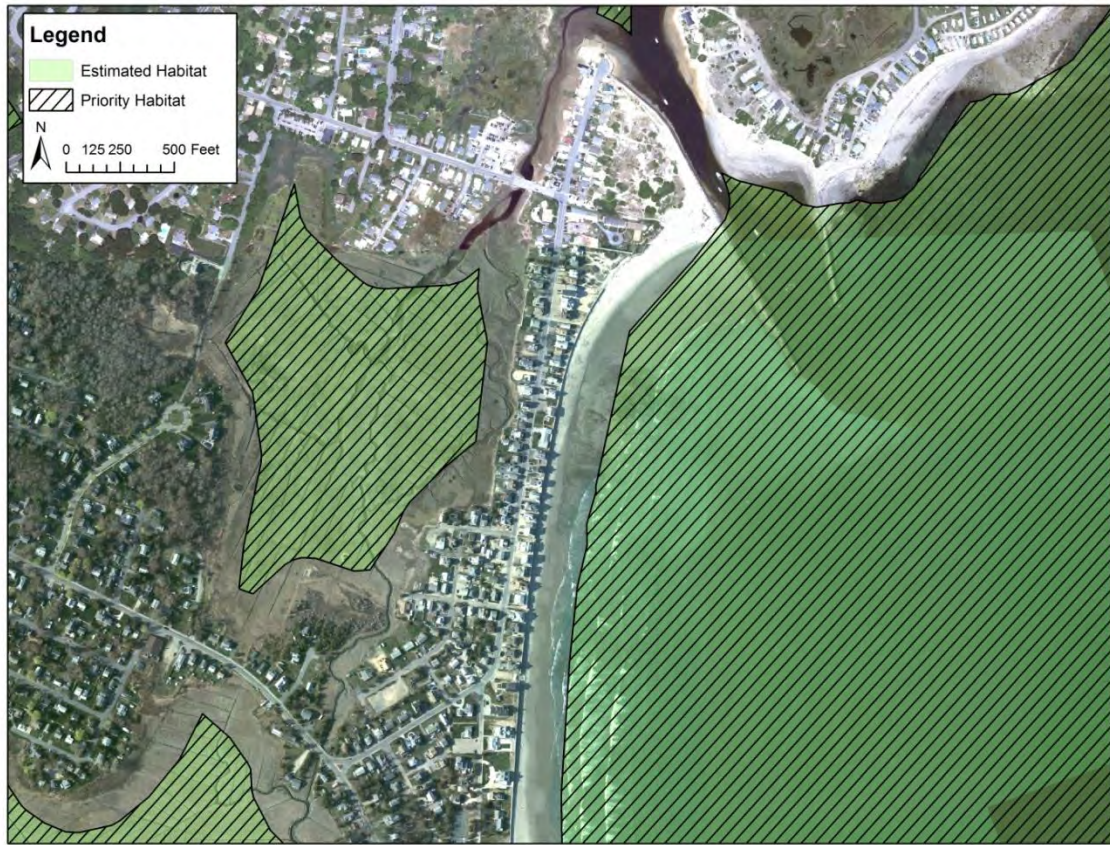
The Natural Heritage & Endangered Species Program (NHESP), part of the Massachusetts Division of Fisheries and Wildlife, is responsible for the conservation and protection of hundreds of species that are officially listed as Endangered, Threatened or of Special Concern in Massachusetts. To better protect and manage these species, the NHESP has developed and outlined areas of Priority Habitats, which are based on the known geographical extent of habitat for all state-listed rare species, both plants and animals. Priority Habitat mapped for the Green Harbor Beach area is displayed in Figure 2-31. Estimated Habitats, another designation of NHESP that represent a sub-set of the Priority Habitats excluding areas specific only to plants, are also present at Green Harbor Beach, and are exactly the same as the Priority Habitat areas. Note that the Estimated and Priority Habitats do not include the coastal beach. Without filing an information request with NHESP, it is impossible to know what endangered or threatened species are present in salt marsh and offshore areas around Green Harbor Beach.

**Figure 2-31. Natural Heritage and Endangered Species Program Estimated and Priority Habitat at Green Harbor Beach.**
