# Marshfield Beach Management Plan FINAL

Woods Hole Group, Inc.  
81 Technology Park Drive  
East Falmouth, MA 02536

**December 2017**

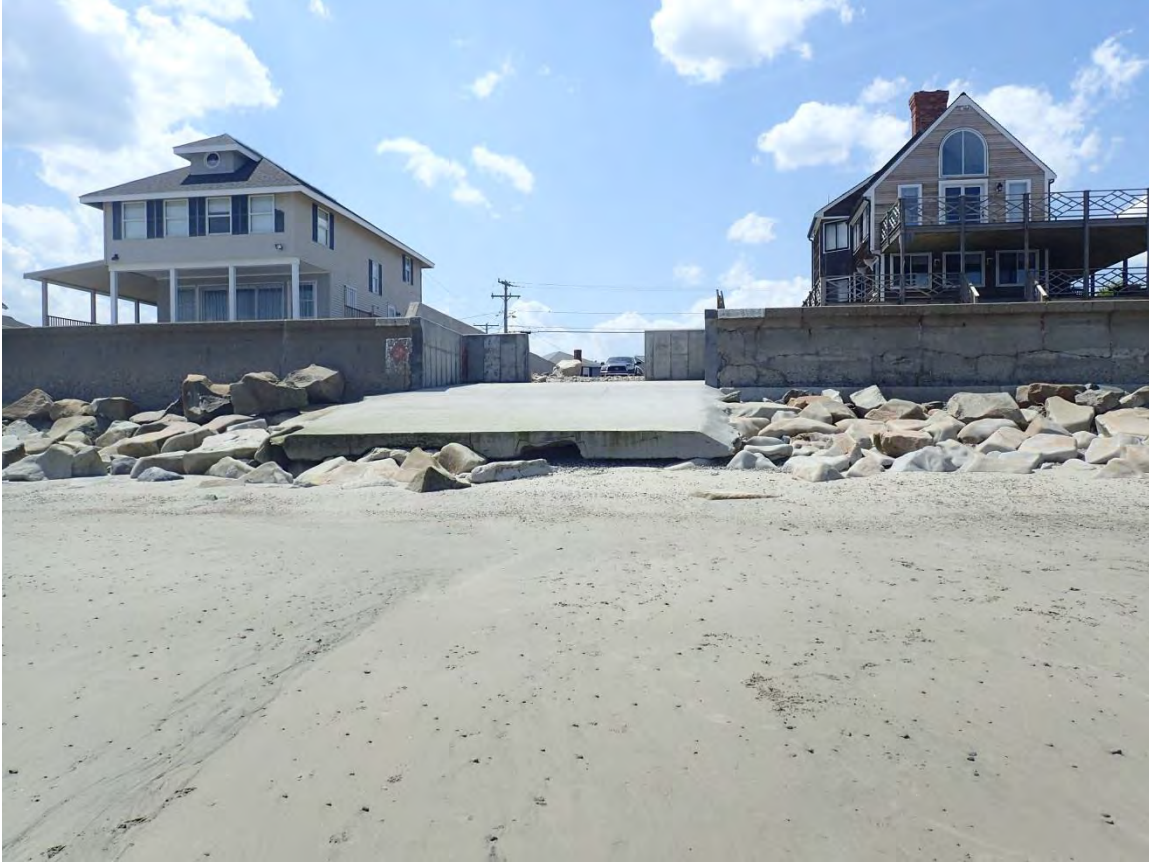
**Figure 2-33. Vertical erosion and lowering of the beach elevation has caused exposure of the access ramp at the corner of Bay Ave and Bay St.**

1930s by the Commonwealth of Massachusetts. The shoreline retreat rates observed in the southern portion of the beach will not continue indefinitely. Given that there is currently little to no dry high tide beach, it is likely that the seawall, if maintained, will prevent any further horizontal retreat of the shoreline in this area. Vertical erosion, however, has started to occur (Figure 2-33). Although obvious in photographs when structures which were previous at or below the beach surface are currently exposed or well above the beach surface, quantification of such change over the entire length of the beach could be measured through targeted low-tide LiDAR data or through field topographic surveys. If the beach profile is lowered enough, the stability and integrity of the seawalls will be threatened. The beach in front of the Bay Avenue seawall is already experiencing this vertical erosion, and may start to undermine the seawall, as it has already done to the access ramp (Figure 2-33).

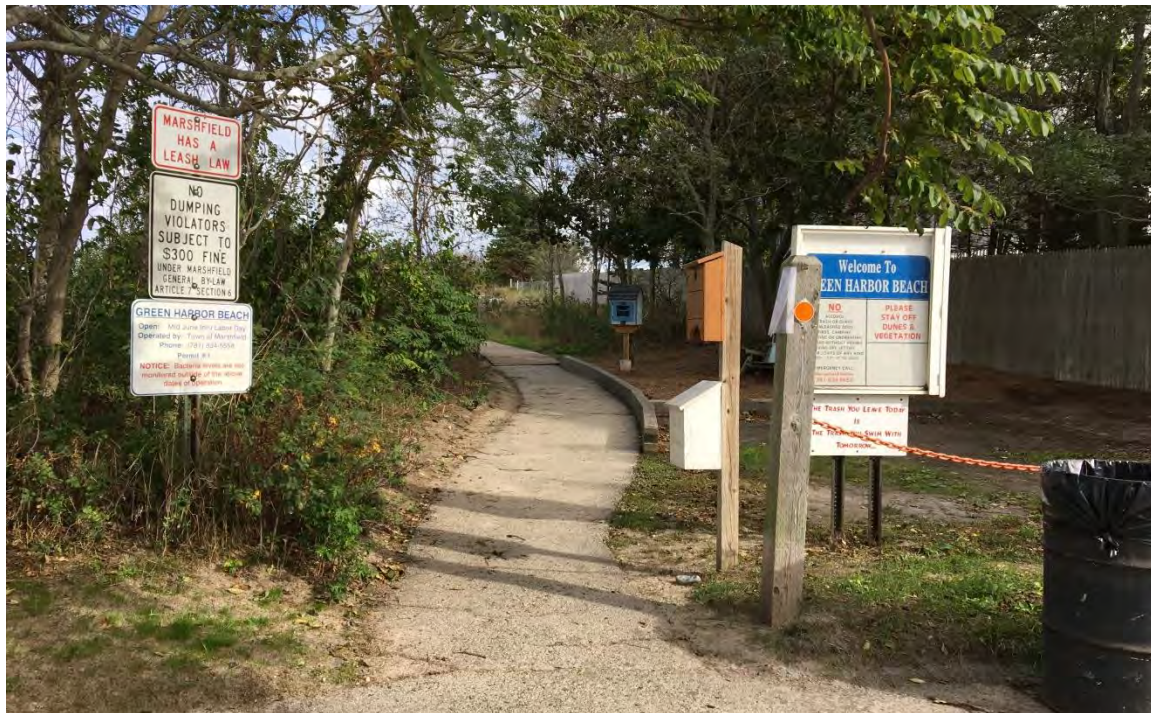
There is a port-a-potty installed at all three parking lot locations during the summer. There are also trash cans, a book box, informational signs, a bench, a dog bag station and a hot dog stand located at the smaller Bay Avenue lot in the summer (Figure 2-36).

**Figure 2-36. Boardwalk entrance to Green Harbor Beach from Bay Avenue parking area.**

The boardwalk from the Bay Avenue parking lot to the beach is fenced along both sides (with chain link fence on one side and sand fence on the other), restricting public access to the boardwalk itself until you reach the beach. Nine additional sections of plastic ramp are installed in the summer to provide a firm surface directly onto the beach. The large undeveloped vegetated coastal dune area north of the path is under a land-court dispute concerning ownership. A wooden snow fence with additional “fingers” (i.e. sections of fence perpendicular to the beach) have been installed at the toe of the dune north of the

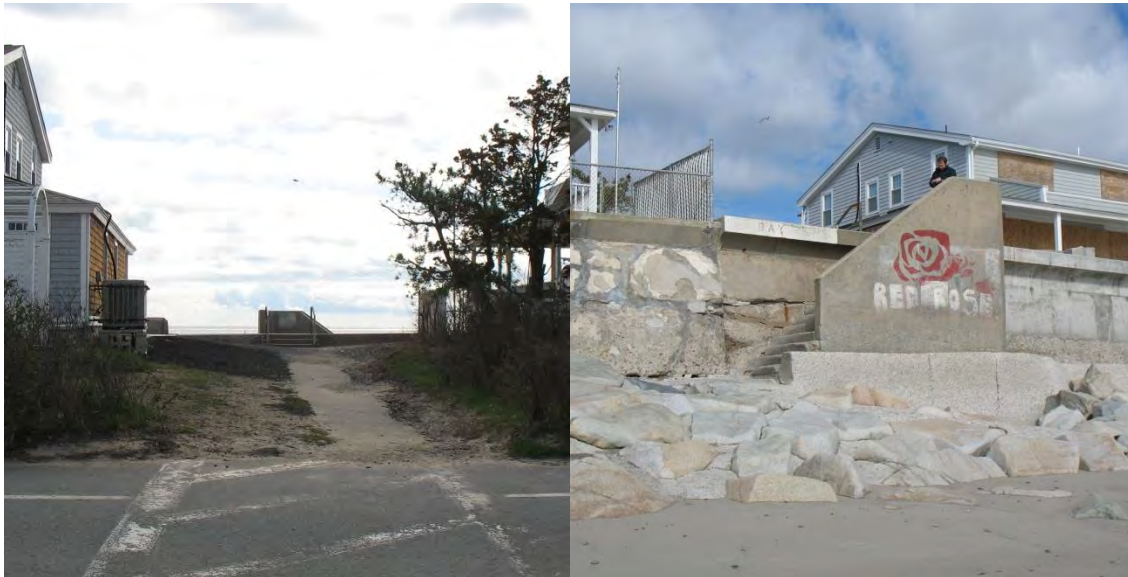
- The main entrance at the Bay Avenue lot has a board walk to the beach;
- Easement pathway along jetty from the northern dead end of Bay Ave;
- 3 easements between properties along Bay Ave; and
  - Between 152 and 148 Bay Ave
  - Between 68 and 64 Bay Ave
  - Between 46 and 40 Bay Ave (Figure 2-37)
  - All three have metal stairs to descend from the seawall, and are accessed from crosswalks on the street. The first access point (between 152 and 148 Bay Ave) is still somewhat sandy and has a narrow high tide beach, but the second two lead to predominantly cobble beaches that are not accessible at high tide.
- A ramp at the corner of Bay Ave and Bay St, which is barricaded, closed in the winter to help mitigate flooding, but contains a welcome sign, book box stand and trash can.

**Figure 2-37. Green Harbor Beach access point on Bay Ave (between 46 and 40).**

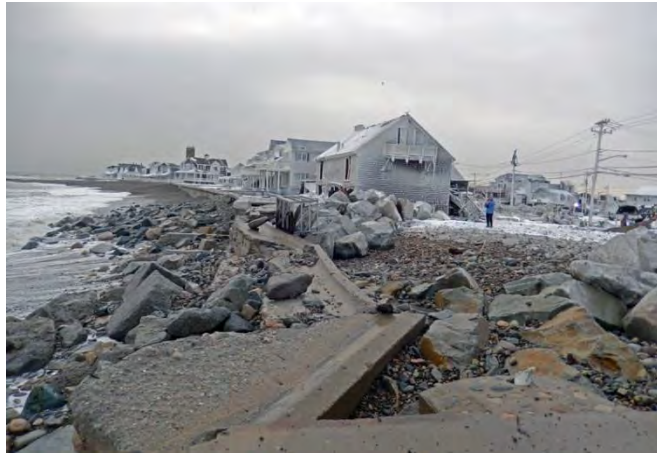
**Figure 4-1. Post-storm Brant Rock Beach (winter 2015).**

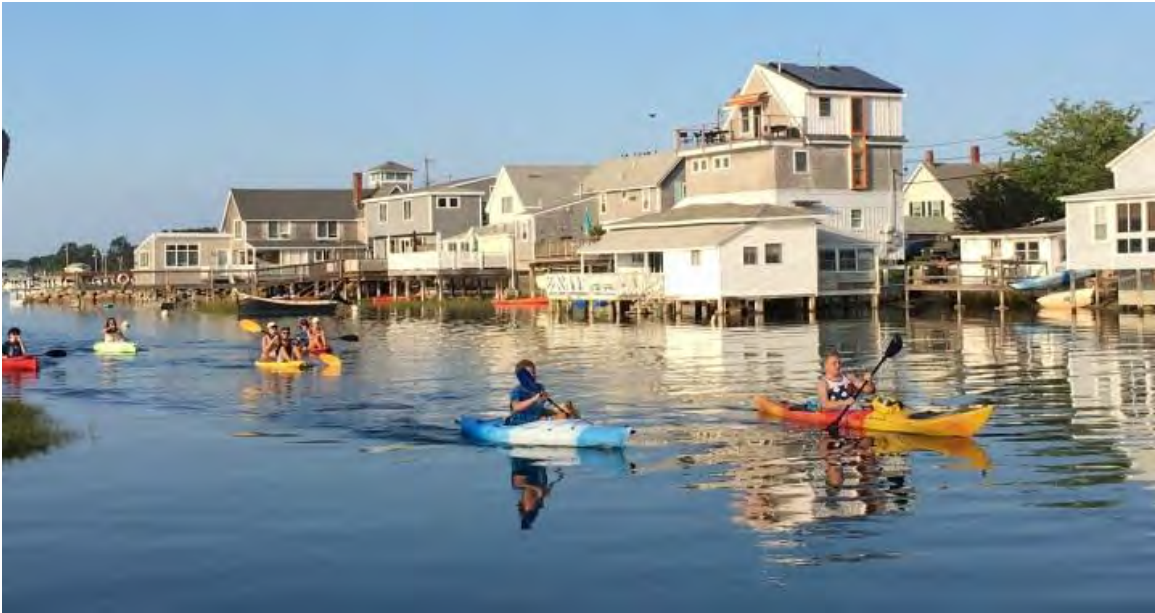
**Figure 3-2. Targeted acquisitions could provide a public kayak launch on the Cut River.**

- 4) Additional and/or Town-owned under-utilized could be used for parking (especially for Fieldston and Sunrise Beach where public parking is essentially non-existent), mini-parks (at Brant Rock and Sunrise Beach, where park areas with shade structures, benches, and or landscaping could be developed to facilitate enjoyment of the beach in areas where use is limited at high tide), and locations for placement of additional beach facilities (i.e. portable toilets, mobile food vendors, educational signs, recreational/educational programming, kayak launches (Figure 4-2), etc.). See Figure 4-3 through Figure 4-6 for some examples of these parcels.

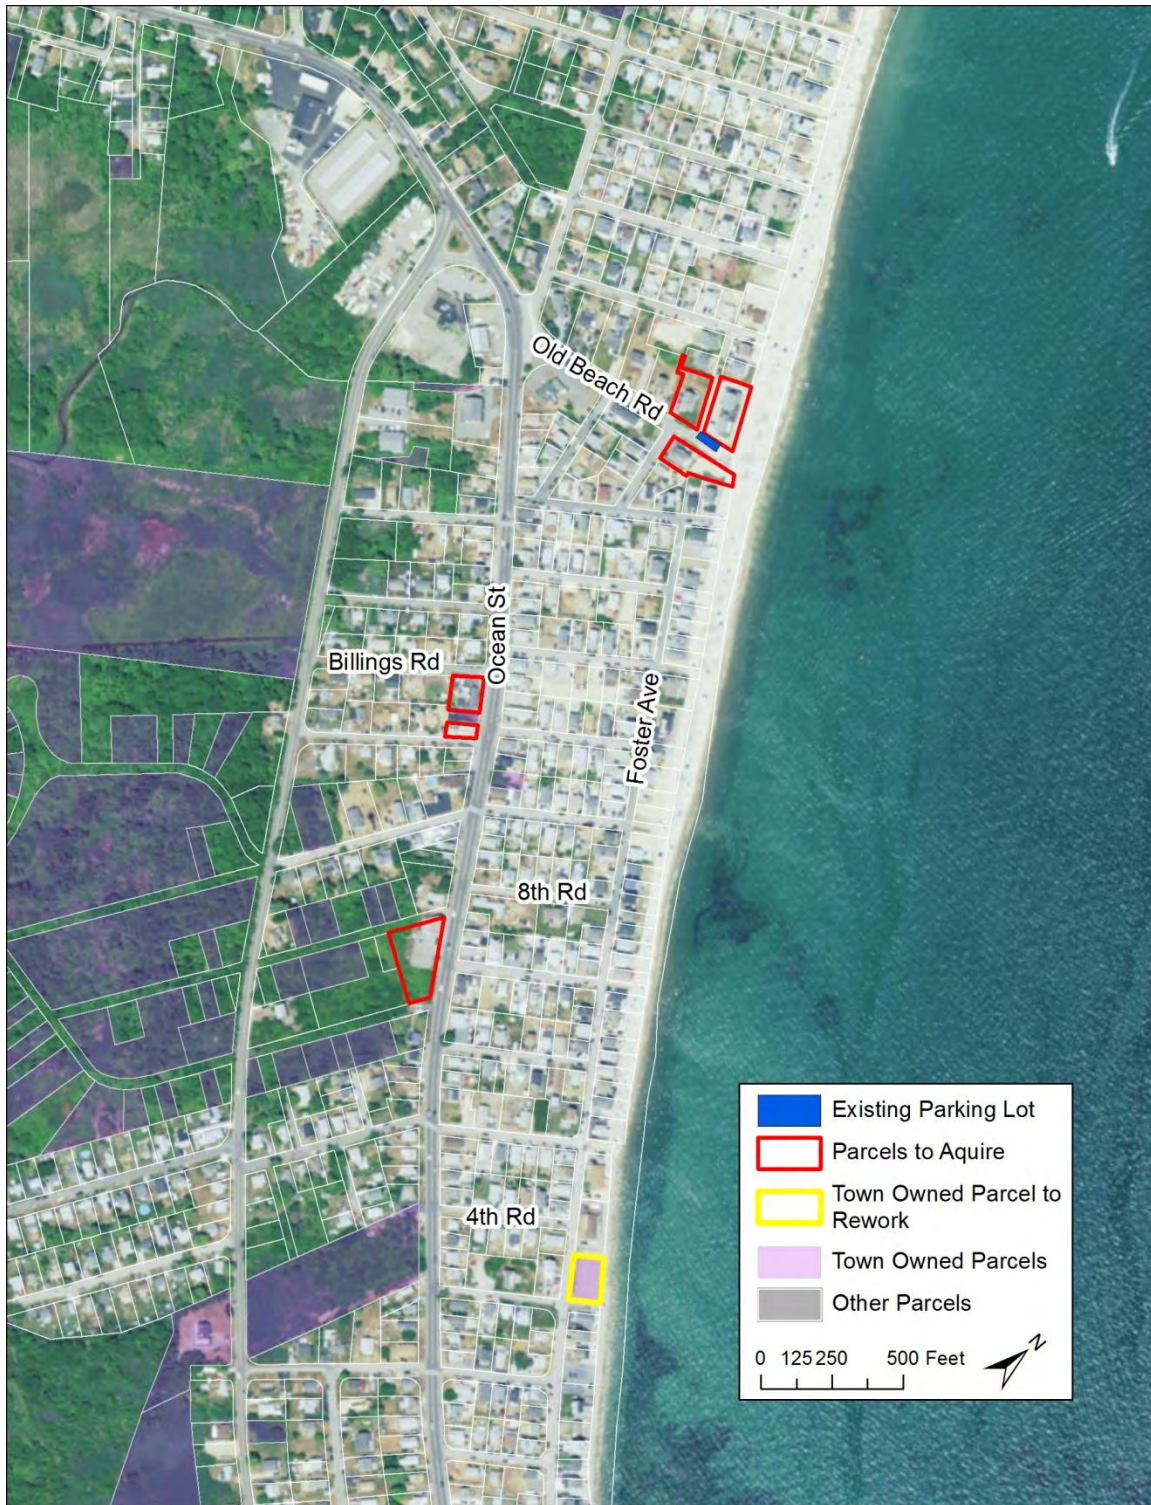
**Figure 4-4. Potential parcels to acquire or rework in the Fieldston Beach area.**

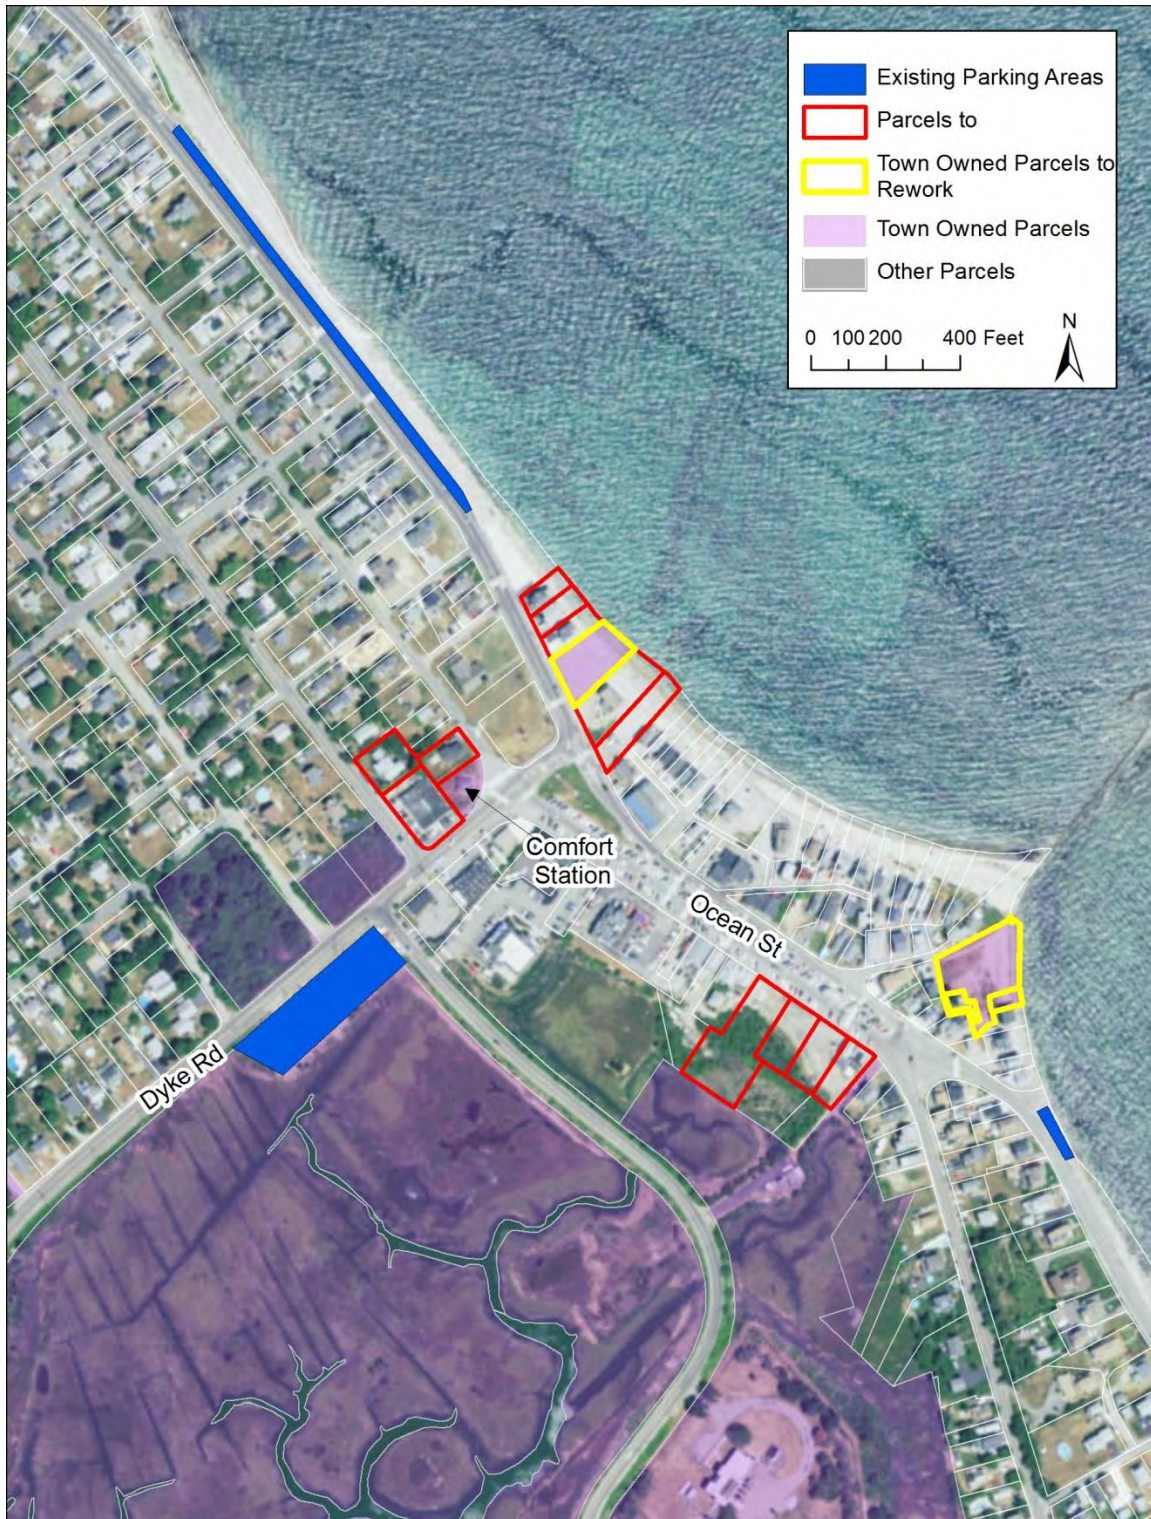
Figure 4-5. Potential parcels to acquire or rework in the Brant Rock Beach area.

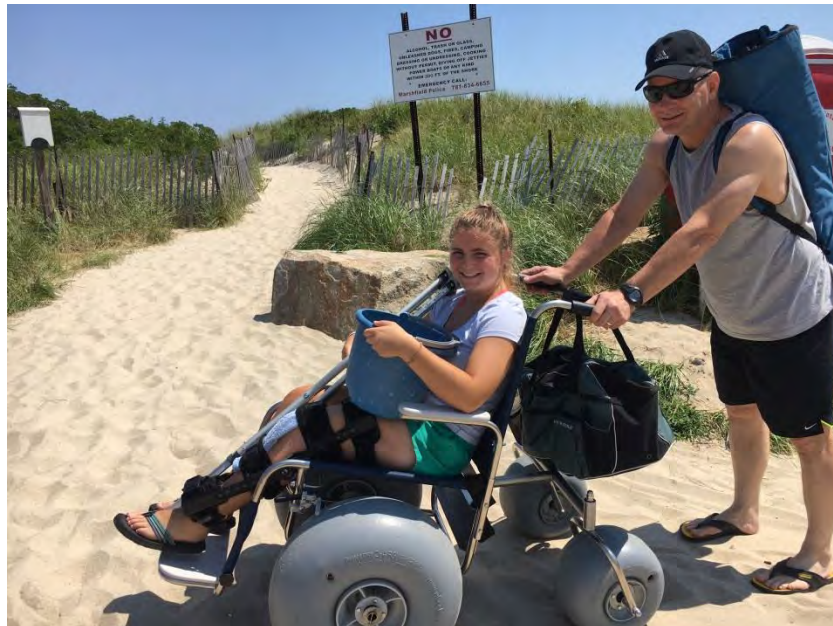
**Figure 4-7. Use of MobiMats would facilitate wheelchair access to Rexhame Beach.**

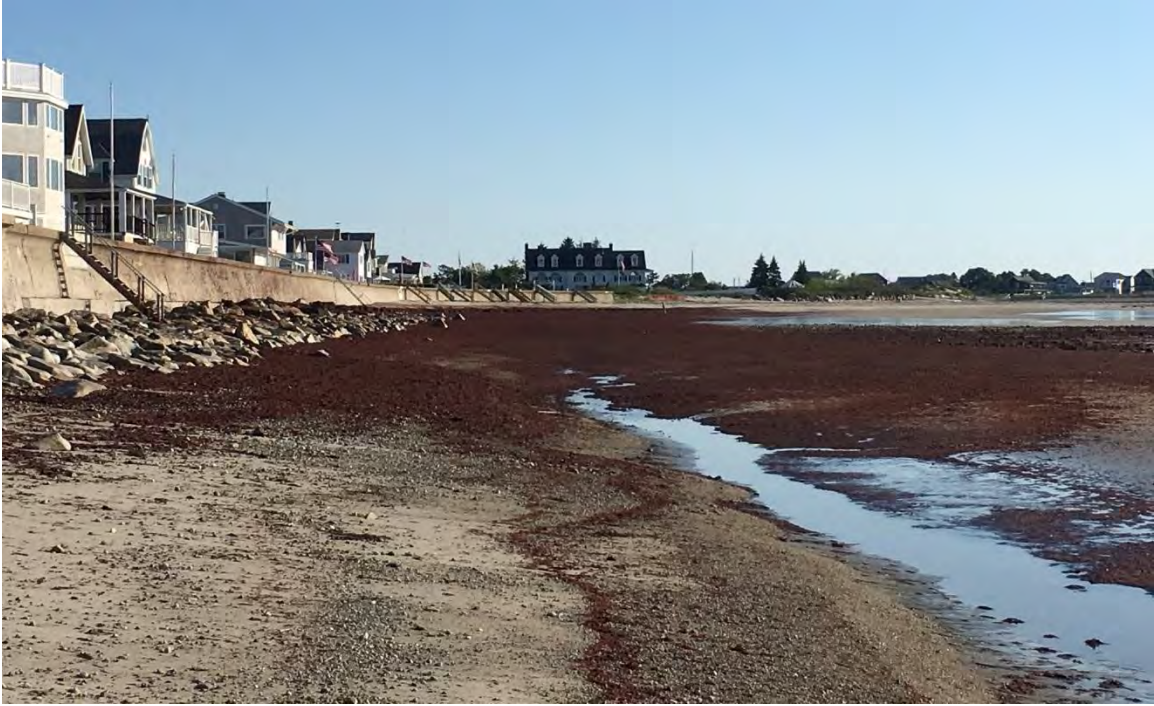
**Figure 4-8. Seaweed accumulated on Green Harbor Beach in June 2017.**

Existing Activities: Beach raking has not previously been performed at any beach. Seaweed is removed when necessary. Minor accumulations of seaweed have been distributed by raking to facilitate its removal by the next tide. Major accumulations, such as at Green Harbor in 2017 (Figure 4-8), were collected and buried on-site by the Department of Public Works using excavators and bulldozers. Large scale seaweed removal has not been necessary at other beaches (i.e. Rexhame, Fieldston) for more than 10 years. In October 2017 a Seaweed Removal Policy was adopted by the Board of Selectmen, the details of which are outlined below.

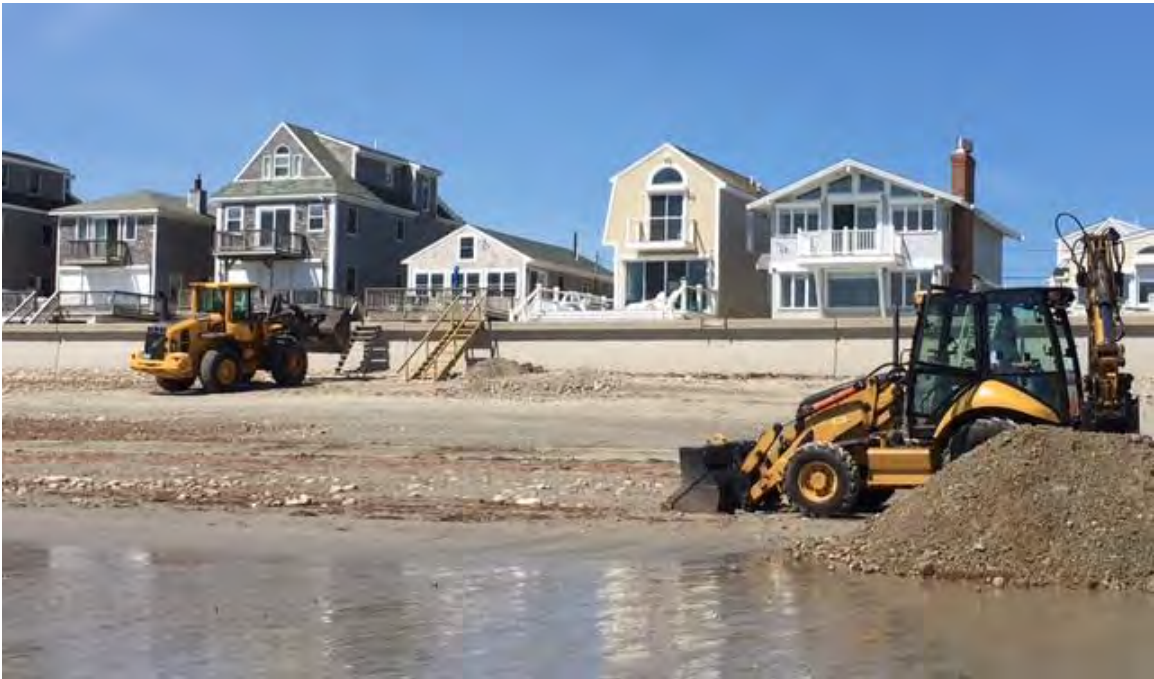
**Figure 4-9. Example of seaweed removal and on-site burial actions from the neighboring Town of Duxbury.**

- b. The secondary means of seaweed removal will be using a bulldozer and excavator to selectively collect and bury seaweed on the beach (Figure 4-9).

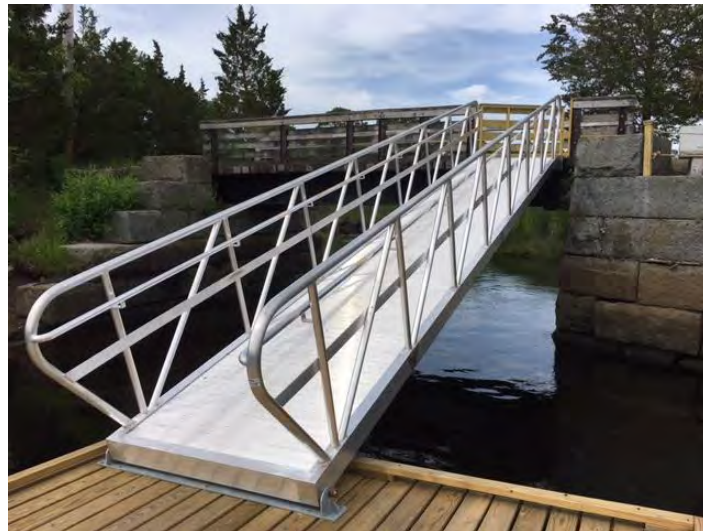
**Figure 4-10. South River kayak launch from upstream location.**

Existing Activities: Visitors currently carry kayaks down to the water's edge from the main Rexhame parking lot. The Marshfield Harbor, Rivers and Waterways Management Plan includes a recommendation for "the establishment of a kayak/canoe rental facility on the Town's waterways." The Town has also recently installed a kayak launch upstream on the South River, behind the CVS on Ocean Street (Figure 4-10).

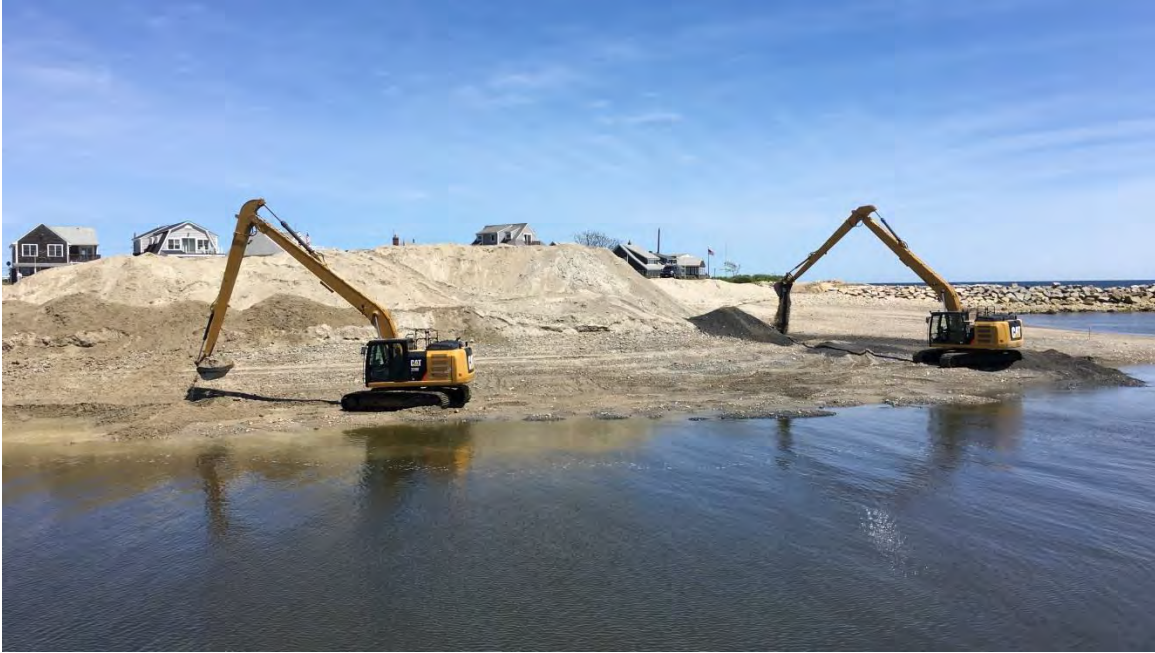
**Figure 4-11. Dredging in Green Harbor 2017.**

- 4) Establish coordination with the U.S. Army Corps of Engineering regarding potential beneficial reuse of sediment dredged from Green Harbor (Figure 4-11). Request early notification by the U.S. Army Corps of Engineers of future dredging so that the necessary agreements for beneficial reuse can be developed. Marshfield is currently undergoing a study funding by the CZM Coastal Resiliency Grants to investigate beneficial reuse; incorporate any recommendations from that study.

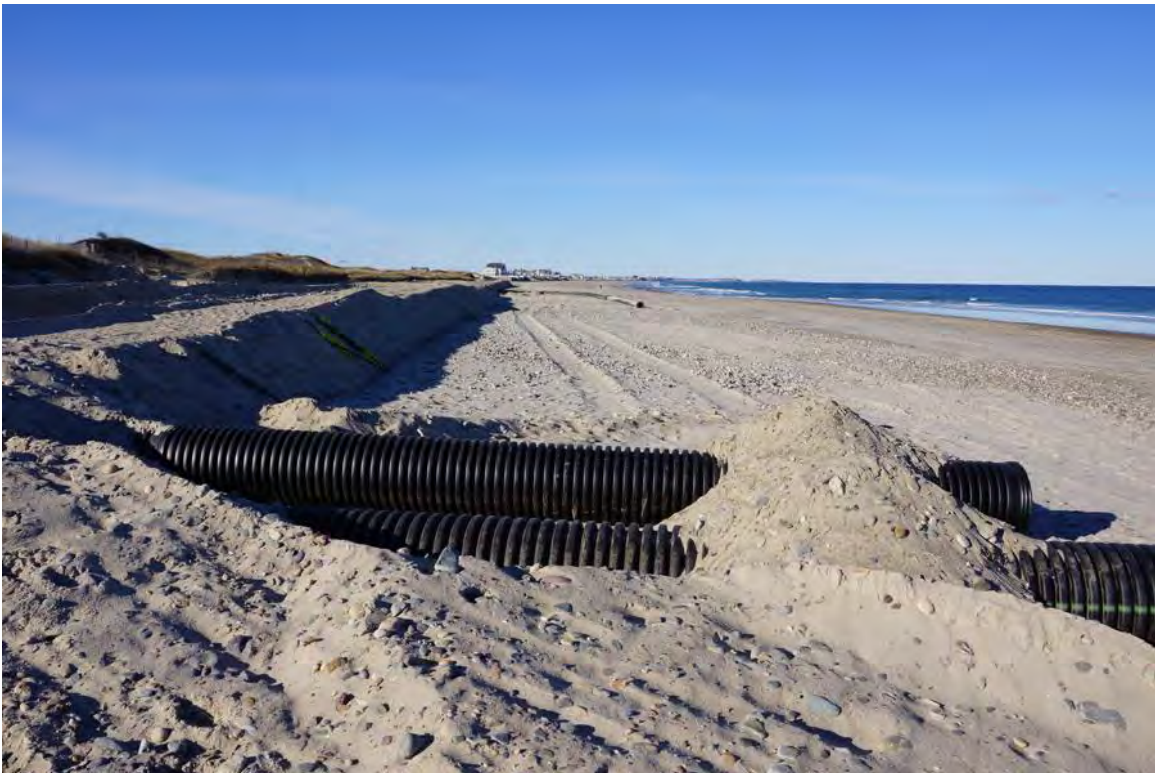
**Figure 4-12. Past nourishment activities at Rexhame Beach have focused on nourishing the beach rather than restoring the dune.**

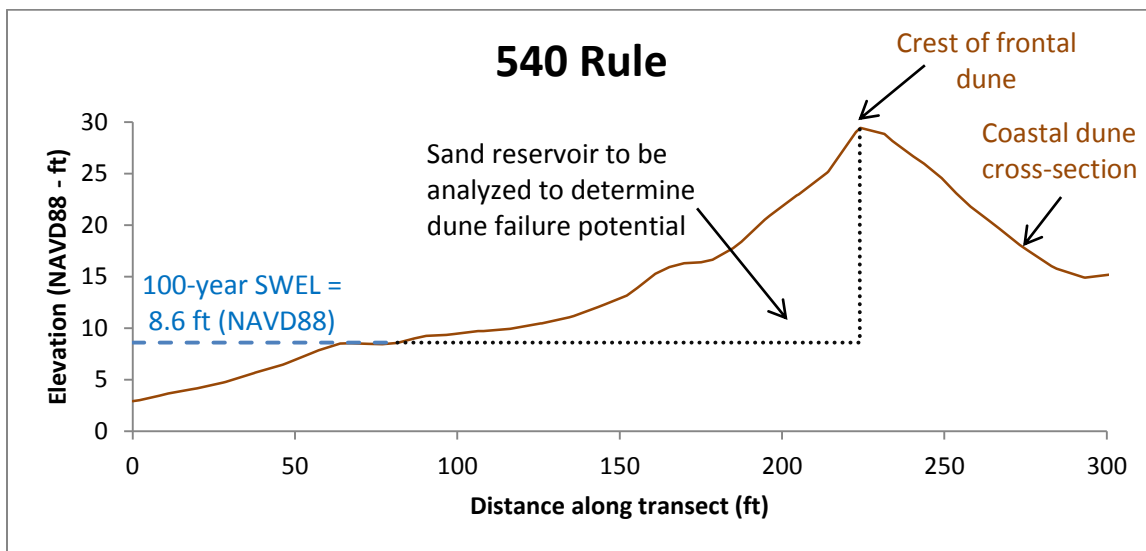
**Figure 4-13. Assessment of the stability of the Rexhame dunes using the 540 Rule.**

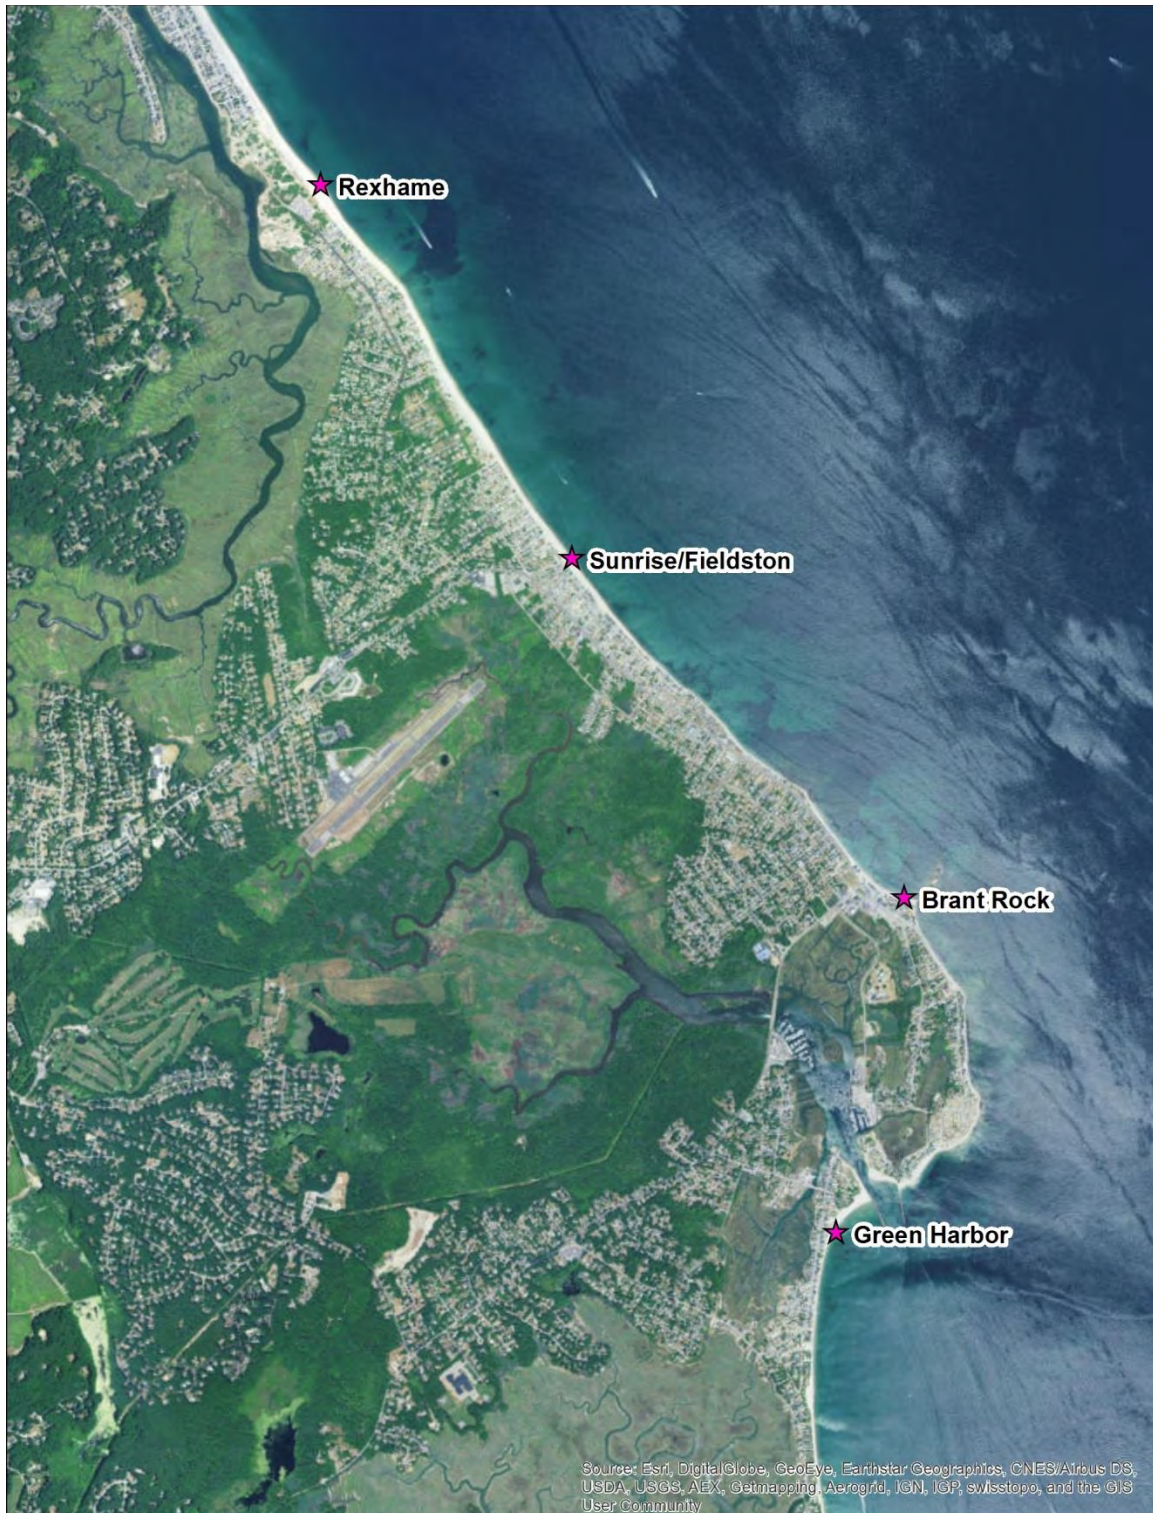
**Figure C-1. Grain size sampling locations.**
