**Sluiceway and Tide Gate Structure
Green Harbor River
Marshfield, Massachusetts**

Inspection Report

**Massachusetts Office of Coastal Zone Management
Wetlands Restoration Program**

**The Louis Berger Group, Inc.
75 Second Avenue, Suite 700
Needham, MA 02494**

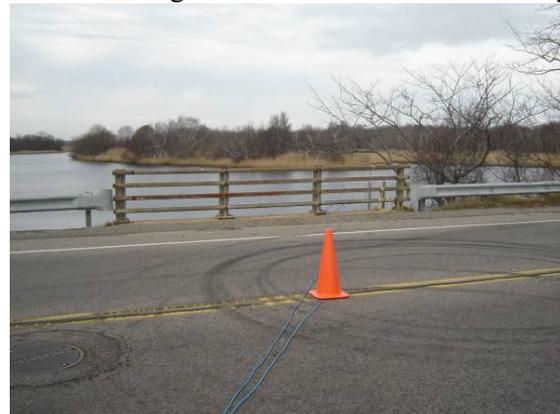
The sluiceway, positioned perpendicular to the roadway above, has very minimal fill above its roof slab to the top of the roadway surface. The structure supports Dyke Road which is comprised of a 42'-0" wide roadway carrying two lanes of traffic (*shown on left*). The roadway is posted for 40 mph and has highway guard rail extending along both sides of the roadway for the length of the dyke structure. This guardrail lines up with metal bridge rail fastened to the sluiceway (*shown on right below*). Utilities present at the site include a water line along the west side of the roadway;

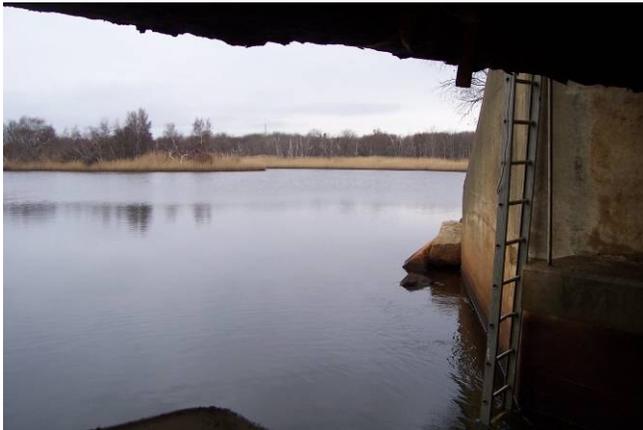
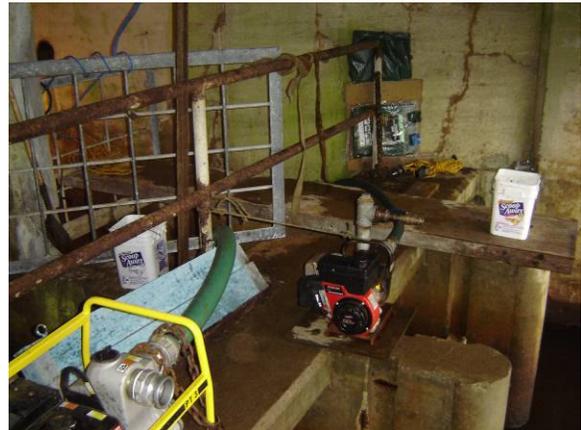
The Town of Marshfield obtained the services of a contractor, Offshore Marine, to provide access to the interior of the sluiceway for inspection. In order to maintain water flow through the sluiceway, the contractor chose to provide access first to the southerly barrel and then at a latter time to the northerly barrel. Access to the southerly barrel was accomplished during an outgoing tidal cycle by blocking the southern barrel of the sluiceway on the estuary side to prevent water discharge through the sluiceway. A submersible pump, placed on top of the invert slab, was utilized to pump down the water within the sluiceway. Approximately 4-5 inches of water remained in the sluiceway during the inspections due to the limitations of the submersible pump and lack of a sump within the invert slab. A ladder was secured to the back of the bridge railing (*shown on left below*), on the northwest corner of the sluiceway, to allow personnel to access the catwalk inside the sluiceway. From the catwalk, timber planks were arranged to provide access to the face of the trash racks. The top section of the trash racks were removed to allow personnel to climb over and down the face of the racks to the invert slab below (*shown on right below*). This same process was repeated to allow access to the northerly barrel of the sluiceway.
