Hurricane and Coastal Storm Damage Reduction Report Feasibility Report and Environmental Assessment *Draft*

Brant Rock and Fieldston Areas Marshfield, Massachusetts

US ARMY CORPS OF ENGINEERS New England District

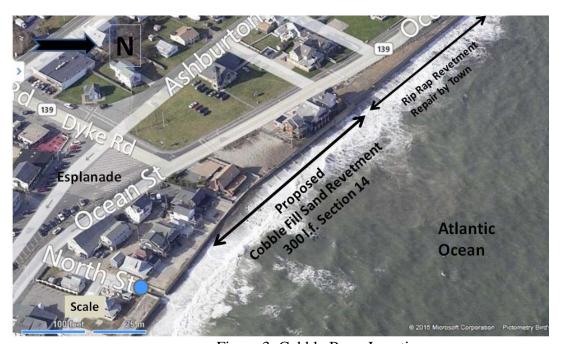
Figure 3: Cobble Berm Location

The seawall protection plan will entail approximately three (300) hundred linear feet of coarse sand to cobble fill be placed as a berm at an estimated cost of \$794,000. The seawall protection plan calls for the placement of a 5 foot wide crest at an elevation of 10 NAVD88 (14 NGVD) and a 1V:6H slope to the beach terminating above MLLW. Figures 3 and 4 depicts the proposed cobble berm location and cross section.

Recommendations: Under the Section 14 authority, it is recommended that in the Brandt Rock section beginning near Franklin Street and extending south approximately 300 feet (Figure 3), a cobble/sand berm be constructed to prevent further beach erosion. Although some wave splash-over would still occur, the continued reliability of the wall would be maintained thus protecting the backshore community from direct attack by frequent coastal storm events.

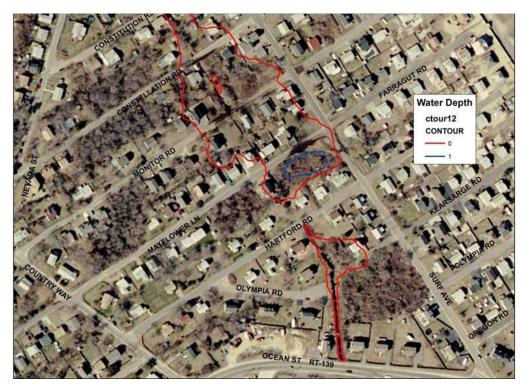
Figure 12. Fieldston Inundation for 2 year storm - existing conditions

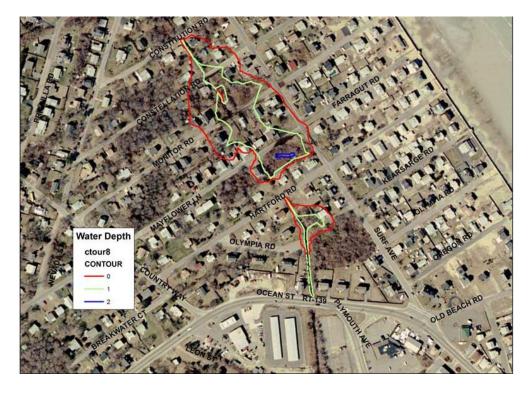
Figure 13. Fieldston Inundation for 10 year storm - existing conditions

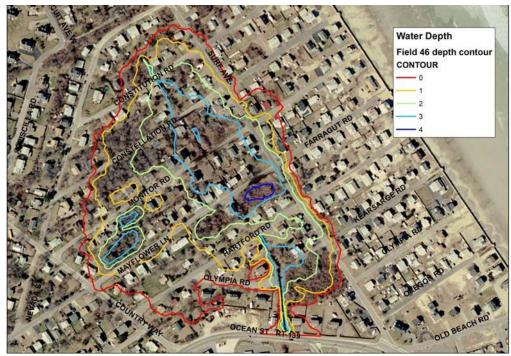
Figure 14. Fieldston Inundation for 500 year storm - existing conditions

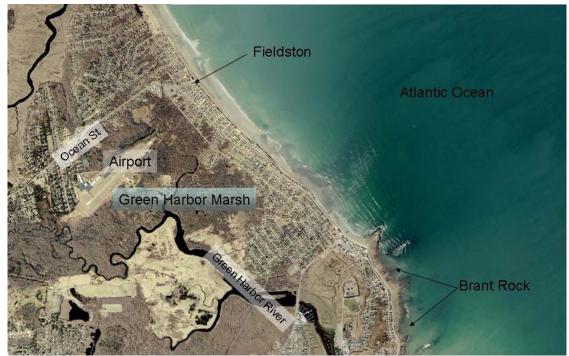
Figure 2 Two study Areas in Marshfield, MA

The study area is comprised of two sites within Marshfield located at the Fieldston Beach area in the north and the Brant Rock area to the south (Figure 2). The combined coastline of these areas is approximately 4,000 feet long and reinforced with a number of stabilization structures, including concrete seawalls, stone revetments, groins, and breakwaters.

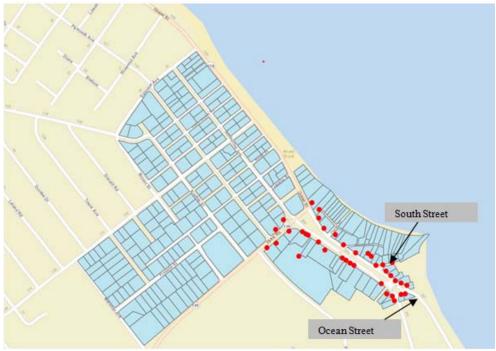
Figure 3 Parcels analyzed for Brant Rock

The Brant Rock study area is fronted by a seawall and bisected by South Street and a stone jetty that runs approximately 475 Feet into the Atlantic Ocean to the geological rock outcropping known as Brant Rock. To the south of the jetty, the beach is cobbled and completely submerged at high tide. A 600 l.f. portion of the seawall is reinforced with a full height rock revetment opposite Knox Street. Several structures, prone to wave damage and flooding, are located in the small area bounded by the seawall, South Street and Ocean Street as shown in Figure 3 below.

To the north of the jetty, the beach is slightly wider. The houses immediately behind the seawall are approximately 20 feet in elevation above the beach, and owners have built stairways to reach the sand below. There is no rock revetment in this area. The elevation decreases to the west toward Ocean Street and Green Harbor Marsh where there is a mix of residential and small seaside town business structures located in an area known as the Esplanade. Flooding at Brant Rock is caused by waves overtopping the seawall and causing water to pool in the low-lying areas of the marsh and Esplanade. According to town officials, the esplanade area floods two to three times a year to a depth of one to two Feet; backing up septic tanks, inundating the Esplanade, and damaging properties in low lying areas. Figure 1 below shows all parcels used in the analysis. Red dots indicate structures surveyed for first floor elevations.
