# FLOOD INSURANCE STUDY

## PLYMOUTH COUNTY, MASSACHUSETTS (ALL JURISDICTIONS)

### Volume 1 of 3

FLOOD INSURANCE STUDY NUMBER  
25023CV001A

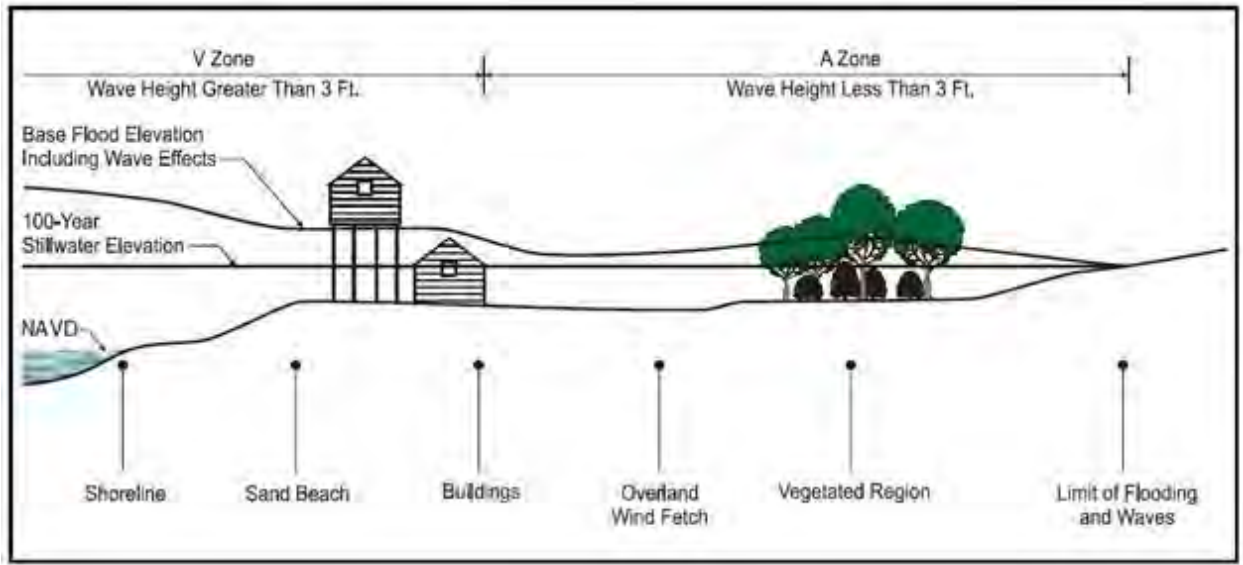
**Figure 1 - TRANSECT SCHEMATIC**

The transect schematic represents a sample transect that illustrates the relationship between the stillwater elevation, the wave crest elevation, the ground elevation profile, and the location of the A/V zone boundary. Figure 1, “Transect Schematic.”
